# Command Decisions and Operations at Rapidly Expanding Incidents

## 9-Alarms at the Orient Heights Yacht Club

April 8, 2000

BOX 6262

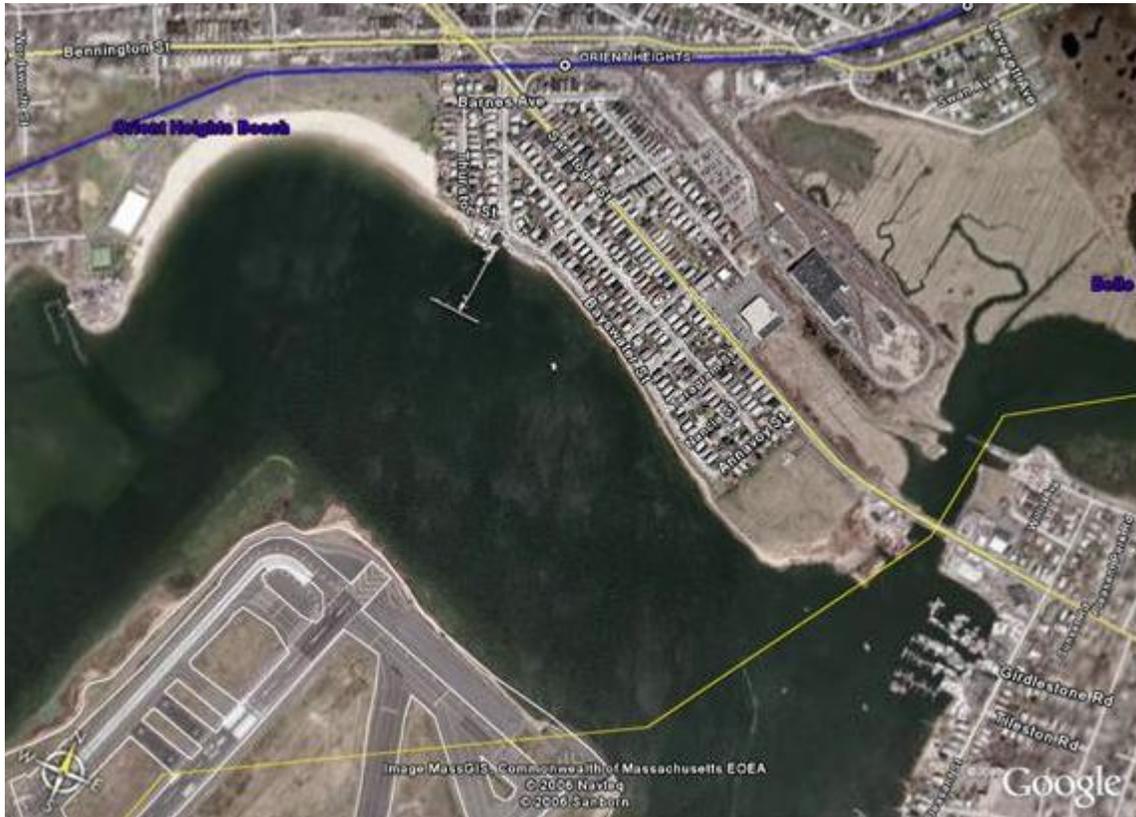
Google Earth view of the Orient Heights Yacht Club on Bayswater St., East Boston.

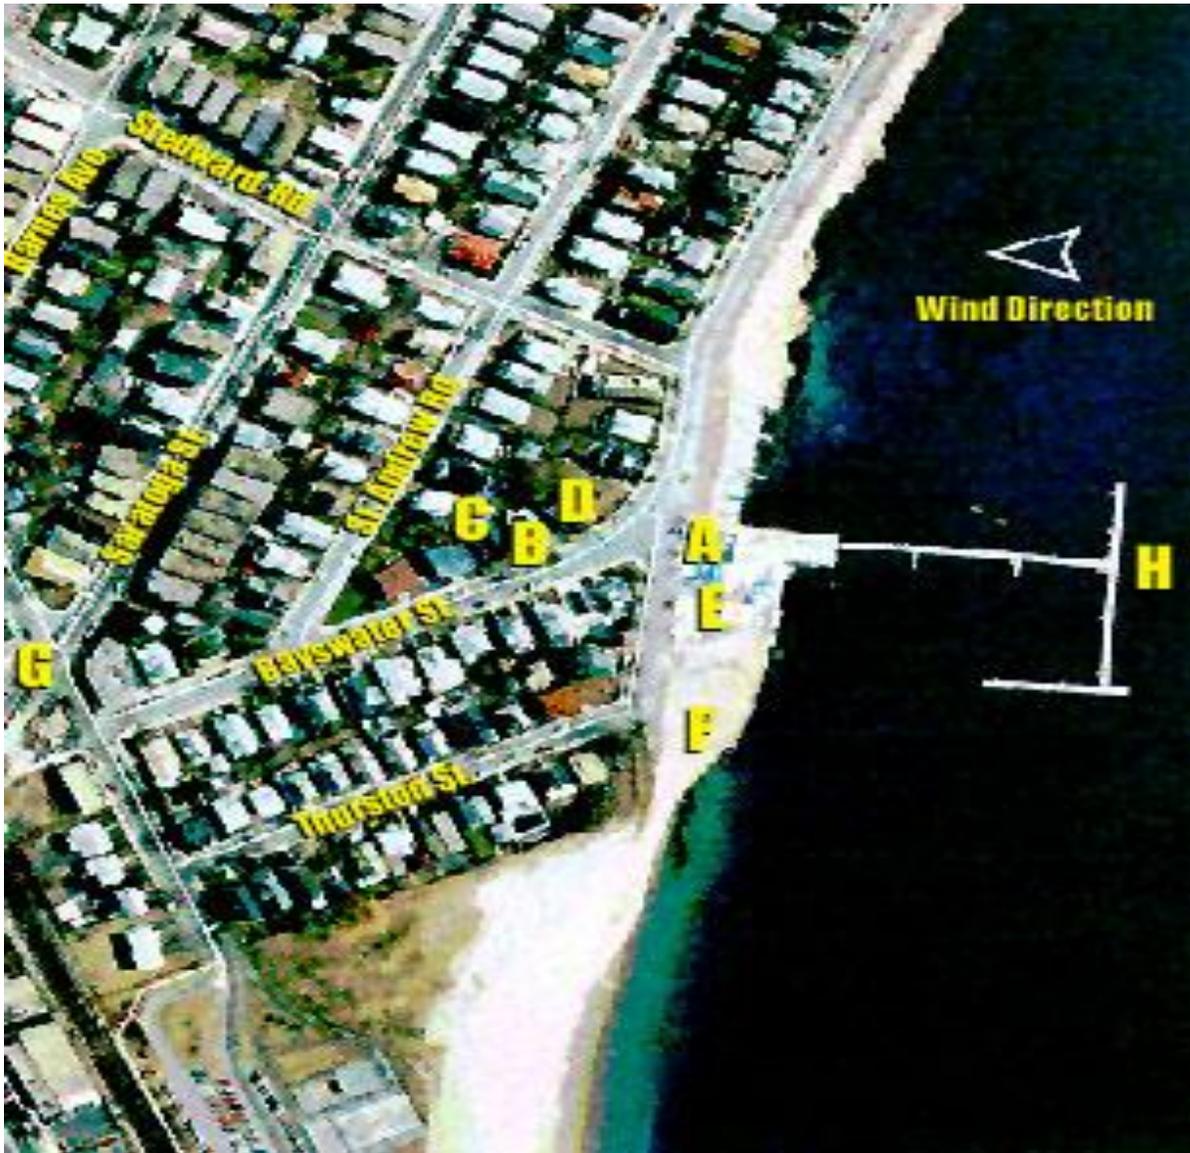
This picture taken from space prior to the fire shows the density of the neighborhood directly downwind of the fire. Flying brands traveled beyond Saratoga St. The fire was accessible only via a bridge on Saratoga St. (G).

- A. Orient Heights Yacht Club (Building of origin)
- B. #54 Bayswater St. (1<sup>st</sup> exposure fire)
- C. #52 Bayswater St. (2<sup>nd</sup> exposure fire)
- D. #60 Bayswater St. (3<sup>rd</sup> exposure fire)
- E. Boat storage adjacent to yacht club (boats shrink-wrapped for the off-season.)
- F. Logan/Massport Foam Unit approaches fire via the beach.
- G. Staging. Access point for all units.
- H. Marine units' position. Firefighters run attack lines along the dock.
