THOSE DEFECTIVE HANGERS.

EXPLANATION OF THE MAIN THEORY REGARDING THE CAUSE OF THE DISASTER—BADLY RUSTED WELDS.

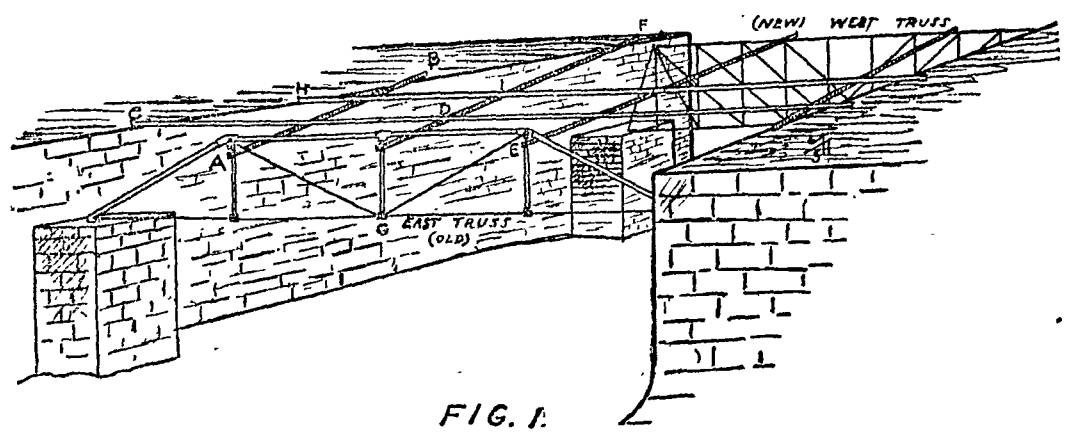
FIG. 1.

Figure 1 shows in outline the general arrangement of the bridge. It will be seen that the two trusses are connected by floor

beams, upon which the two stringers are laid. Upon these stringers are laid the cross-ties and rails of the track, which are not shown in the drawing. Both floor beams and stringers are trussed; the rods are, however, not shown.

The first two floor beams, AB and DF, are hung at one end from the chord of the old truss, while the other end rests upon the abutment, owing to the skew. On these rest the stringers HI and CD. A is the "end joint block," from which was hung the floor beam AB by the hangers or stirrups mentioned in the railroad commissioners' hearing, and which have been

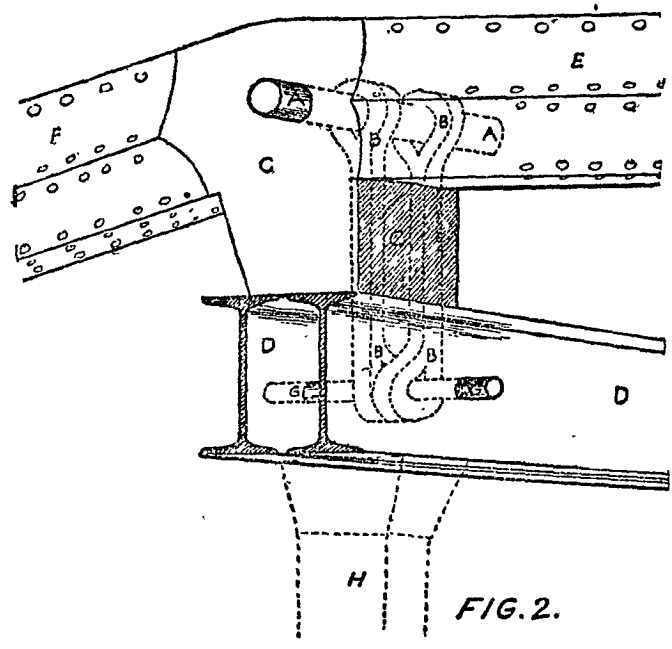
FIG. 2.

The location of these hangers is shown (with diagonals and bracing removed) in Figure 2, where FF is the inclined end post and EE the top chord, each of which bears upon the end joint block CC. Through this casting passes the pin AA, and from this pin the floor beam, DD, is hung by the hangers or stumps, BB. The pin AA also passes through the upper loop of the hangers, and a pin, GG, passes through their lower loops and

all through the two I beams, DD, thus suspending the floor beam. The hangers being inside the box-like casting, CC, it is evident that it was impossible to inspect or to paint them, a portion of the lower ends only, at BB, being visible. Under the floor beams is the post H, which, however, gives little support.

The appearance of these hangers has led to the theory that they gave way first, allowing the floor-beam to drop (the post H toppling over) and the train to cut through the bridge, tearing down the trusses.

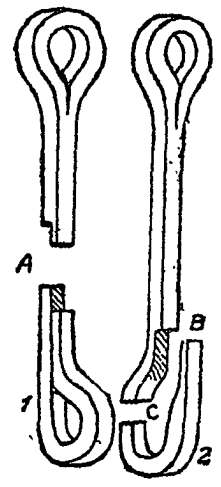
FIG. 3.

Fig. 3, where the rusted section is shaded. It will be seen that A is evidently an old break, being almost entirely eaten across by the rust, besides being split up from the eye along the line of the weld. The other link is more perfect, C being evidently a fresh break, although it is rusted and split along the weld to B. The form of these links is such as to cause what is called "eccentric loading," because the centre of the lower eye is not in

- FRACTURE AT A
- FRACTURE AT B (RUSTED ALL ALONG. WELD)
- FRACTURE AT C (NEW BREAK)

The appearance of the broken hangers, with the fractured sections, is shown in

the line of the pull, the lower loop acting precisely as a hook would, thus bringing a great bending strain, which would naturally cause it to break at C. It is the pieces numbered 1 and 2 that disappeared soon after the accident and which are reported to be in the possession of the "Engineering News."
