INVESTIGATION

COLLAPSE

HOTEL VENDOME

CITY OF BOSTON

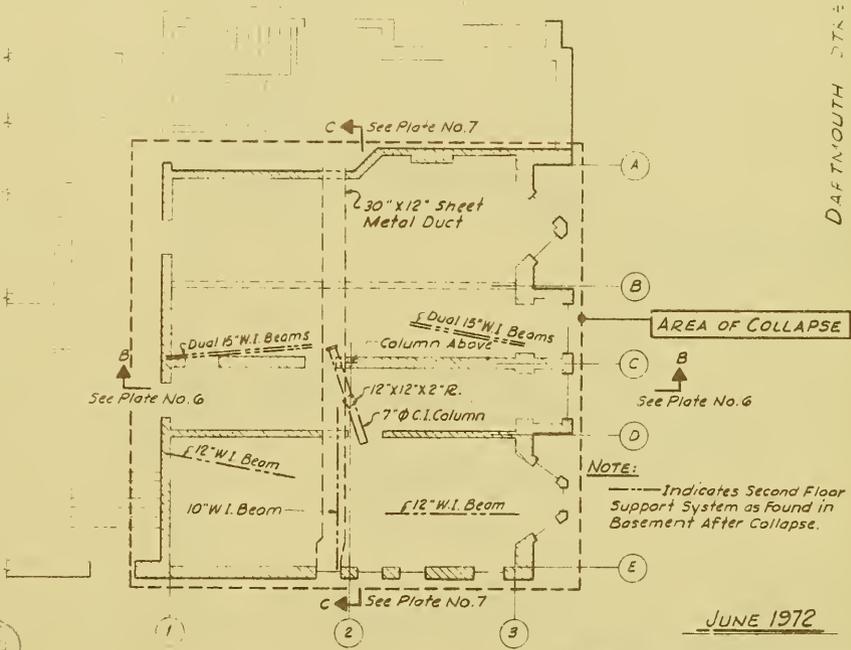
PLATE No. 3

Several metal beams were uncovered below the second story. (See Photos No. 10, 11, 12, 13 and 14). After the debris was carefully removed, a column (with an attached cap plate) and an isolated plate were found in the basement near the center of the area. (See Photos No. 15, 16 and 17). The column, though displaced, was intact, evidence that of itself it was not the cause of the failure. The isolated plate, later identified as being the base plate, was found alone on the basement floor. (See Plate No 3).

at hand. Sometime in the latter part of 1971, additional alterations to the wall on C-Line in the basement story were undertaken. These alterations consisted in part of an installation of a 30 inch by 12 inch sheet metal air intake duct.

In the first half of 1972, the B-Line Masonry Wall was also removed and shores placed.

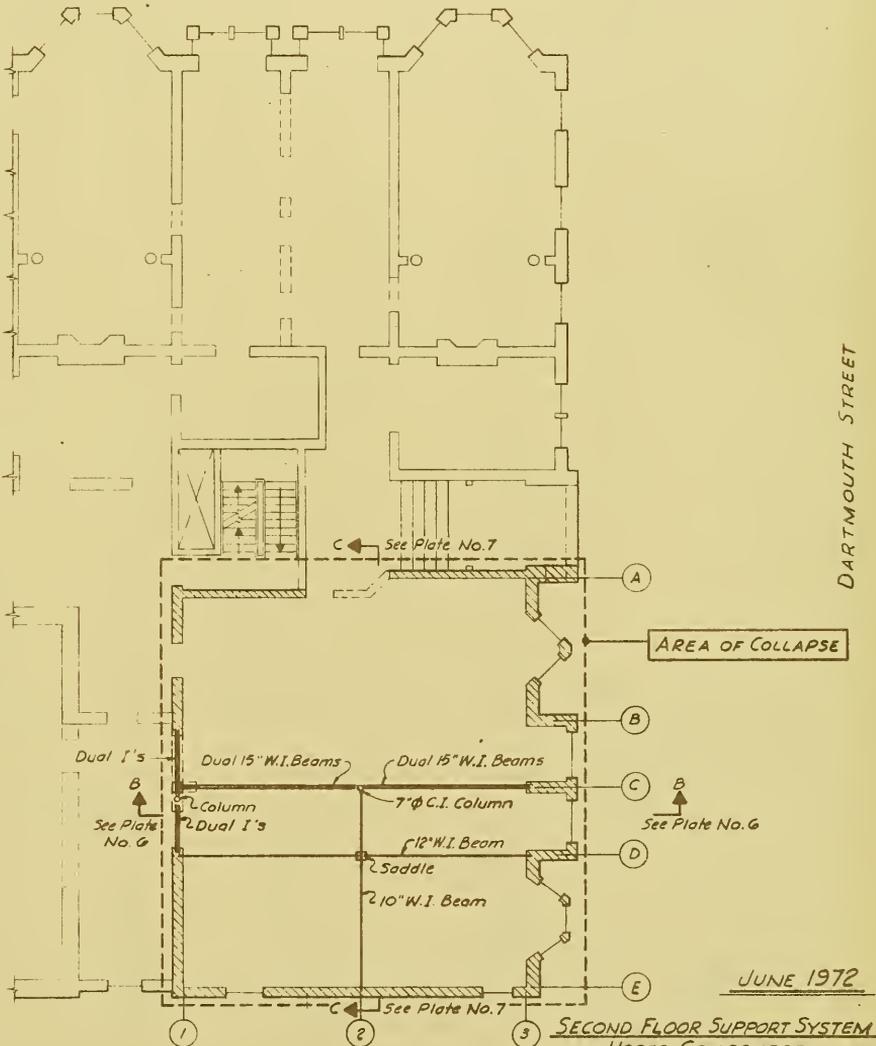
PLATE No. 4

Sometime around 1890 or before, alterations in the first story were made. The C-Line Wall and the partition on the D-Line were removed in this first story. Dual 15-inch wrought iron beams, together with a 7-inch diameter cast iron column at Line 2 were installed to carry the loads of the second floor and the floors above previously carried by the section of wall removed. The partition on the D-Line was replaced by 12-inch wrought beams suspended by a saddle on a 10-inch wrought iron beam spanning between the C-Line and the E-Line along Line 2. The 7-inch diameter column on Line 2 was based on a 12-inch by 12-inch by 2-inch plate directly over the lower portion of the wall at the C-Line.

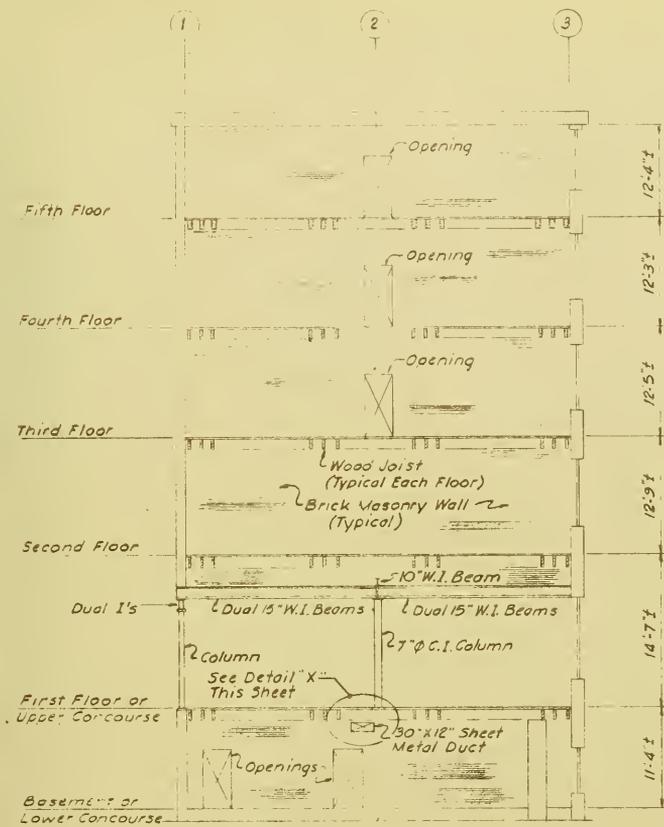
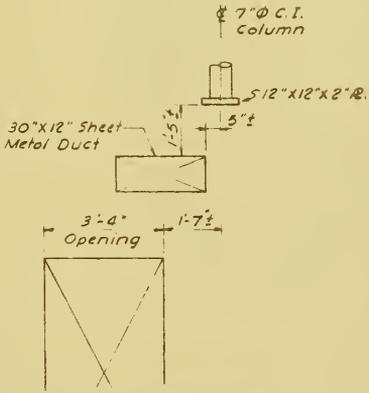
PLATE NO. 6

The 30 inch by 12 inch metal duct passed through the C-Line Wall in the vicinity of an existing doorway. The top of this duct was approximately 17-inches below the underside of the column base plate. The side of this duct was within 5-inches of the centerline of this column.

The opening required for this duct was therefore in a very critical location in relation to the bearing area of the column and base plate.

When the opening for the air intake duct was made through the wall, the bearing stress at the side of the opening, already too high, was greatly intensified and was approaching a critical stage. It should be emphasized that in computing these stresses no live load was considered.

With the addition of even a small live load or a slight moving load, it is probable that failure by crushing of the masonry in the area at the side of the opening could have been easily triggered, thus causing the tilting of the column base plate, the displacement of the column and the complete loss of support.

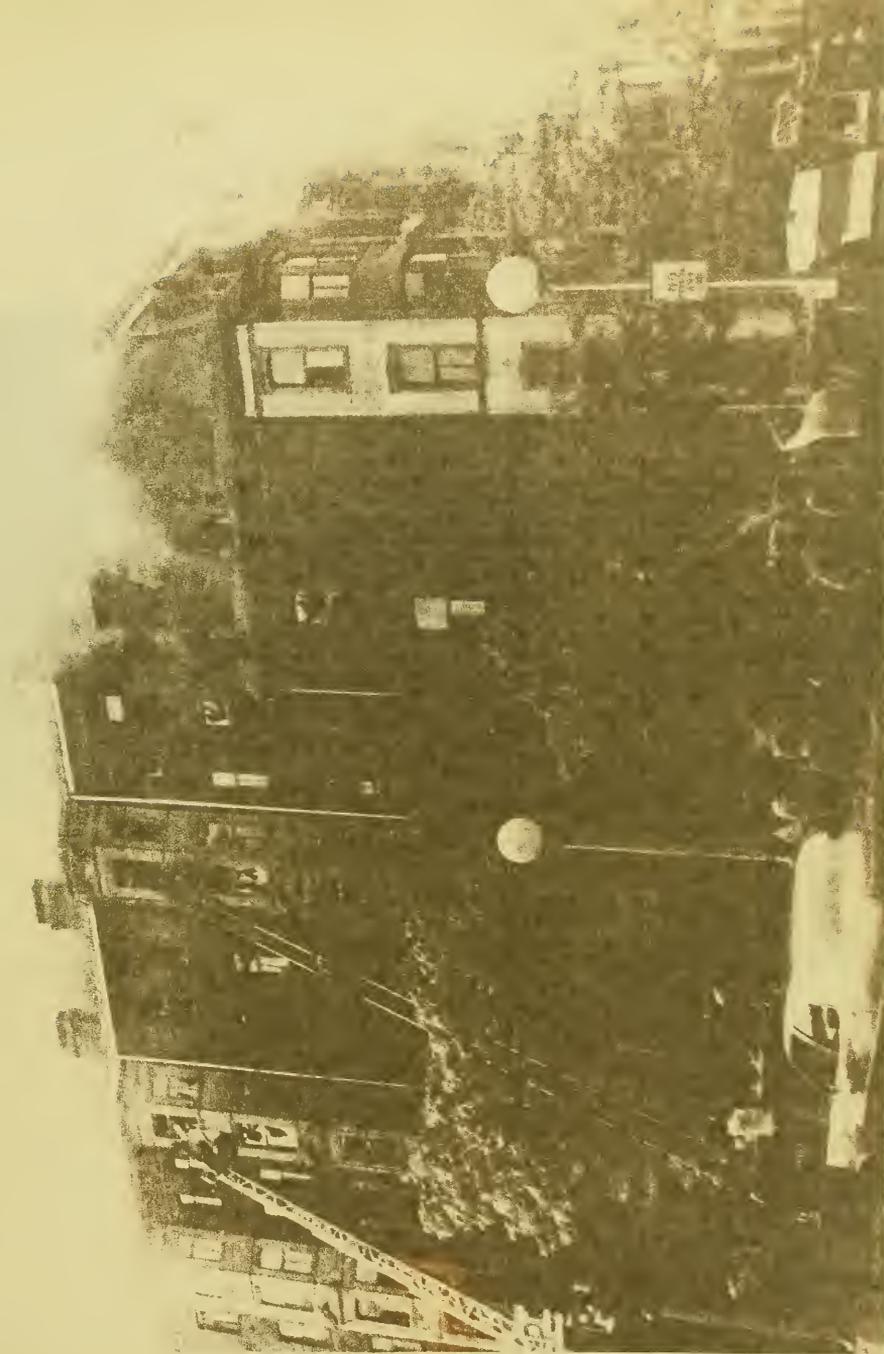
Photo A

In the late afternoon of Saturday, June 17, 1972, the Boston Fire Department suffered the worst disaster in its history when nine firefighters were carried to their deaths and several others were injured in the collapse of the southeast section of the old Hotel Vendome located at the corner of Commonwealth Avenue and Dartmouth Street, Boston. (See Photo A).

SOUTHEAST SECTION DURING FIRE

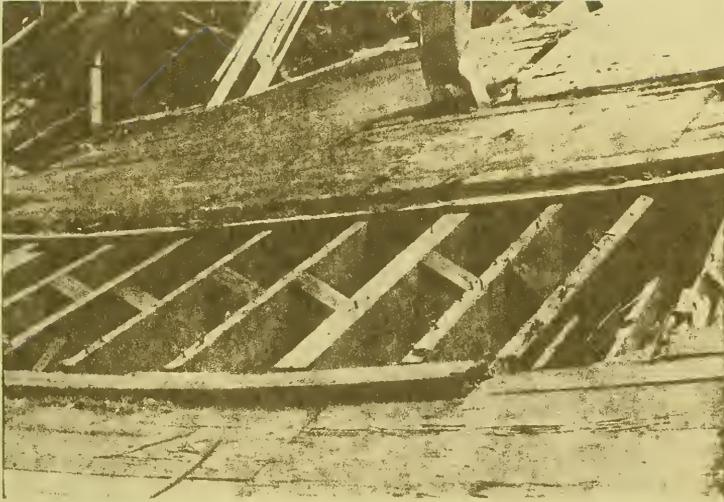
Photo No. 1

The floors in general were of hardwood applied on a layer of tongue and groove sheathing on a mortar of gypsum fill over a tongue and groove wood sub-floor. The supporting joists were of wood and were parallel to Dartmouth Street. It is thought that the fill was for the reduction of sound transmission between floors. A portion of the first floor surface appeared to be of some material other than wood. (See Photo No. 1).

FLOOR, TYPICAL
SECTION

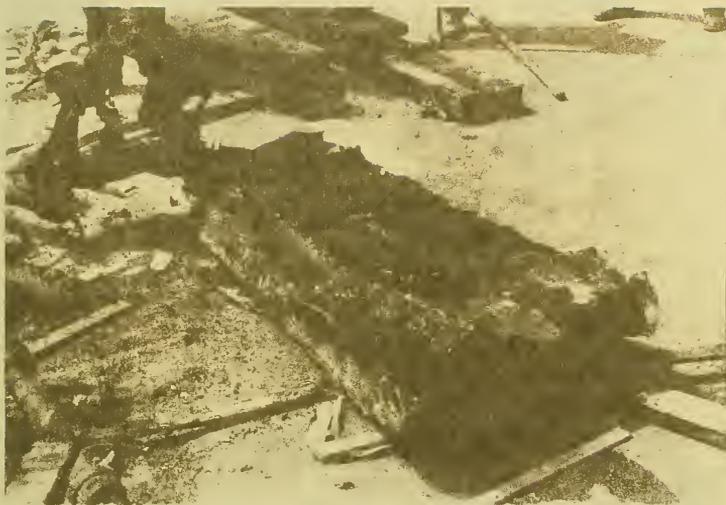
Photo No. 2

The roof construction appeared to be of tar and gravel on wood sheathing with wood joists supported on masonry walls. (Subsequently, a leveling fill of concrete was placed over the existing roofing and a wearing surface of quarry tile was installed).

ROOF, CONCRETE
FILL AND
SHEATHING

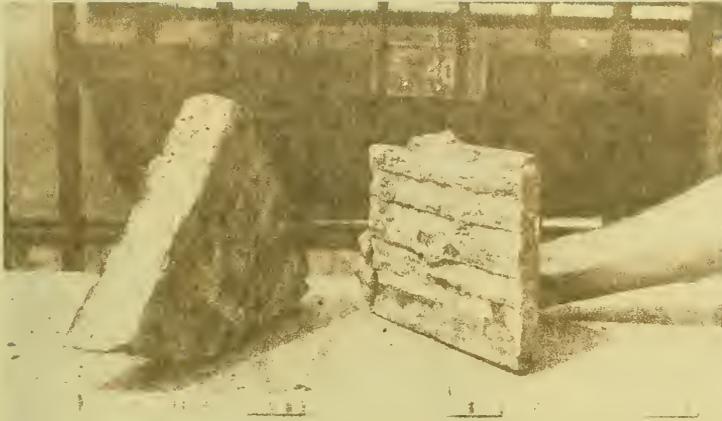
Photo No. 3

ROOF, CONCRETE
FILL AND QUARRY
TILE

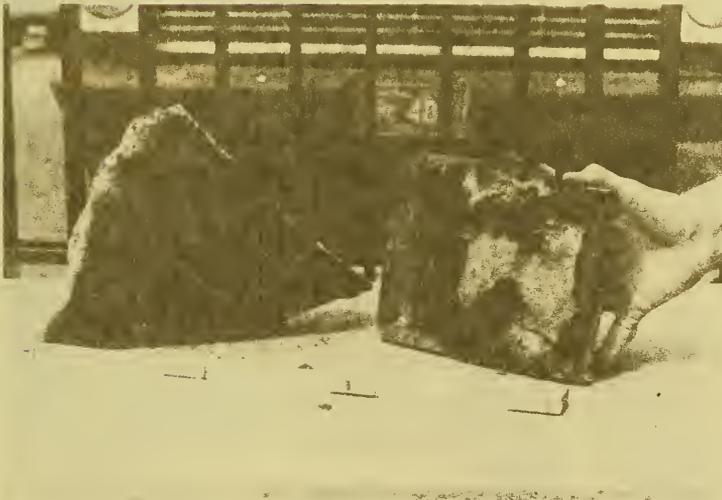
Photo No. 4

ROOF, CONCRETE
FILL AND QUARRY
TILE

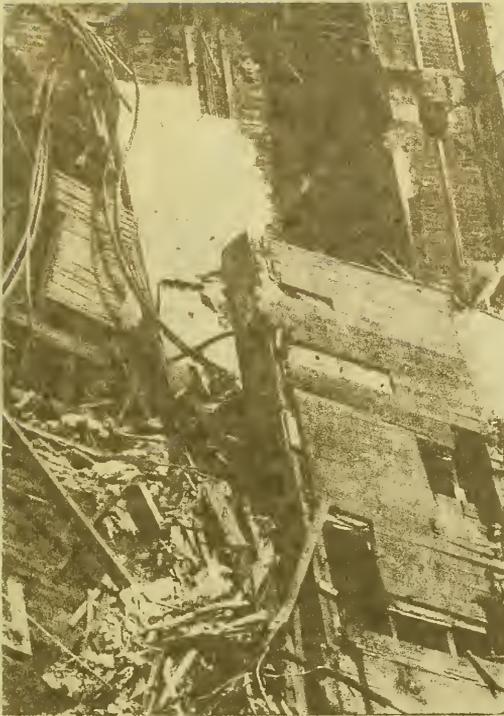
Photo No. 5

Large portions of the floors in the area between the A-Line and the C-Line were found stacked against the A-Line Wall. These portions were in an inclined position and were relatively undamaged. (See Photo Nos. 5, 6 and 6A). The portions of the floors between the C-Line and the E-Line were severely damaged. In general, the top surfaces of these floor sections were relatively undamaged with no evidence of sufficient debris to contribute to the collapse. Field measurements provided substantial verification of the original construction.

FLOOR PORTIONS AGAINST A-
LINE, BETWEEN A-LINE AND
C-LINE

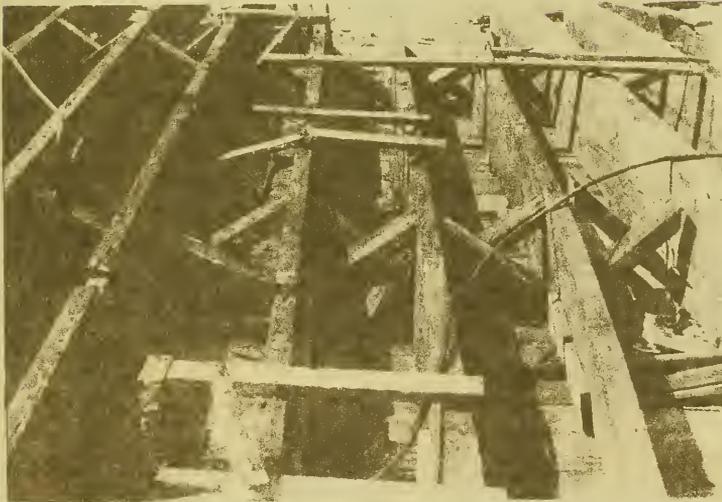
Photo No. 6

RELATIVELY
UNDAMAGED FLOOR
PORTIONS AFTER
REMOVAL

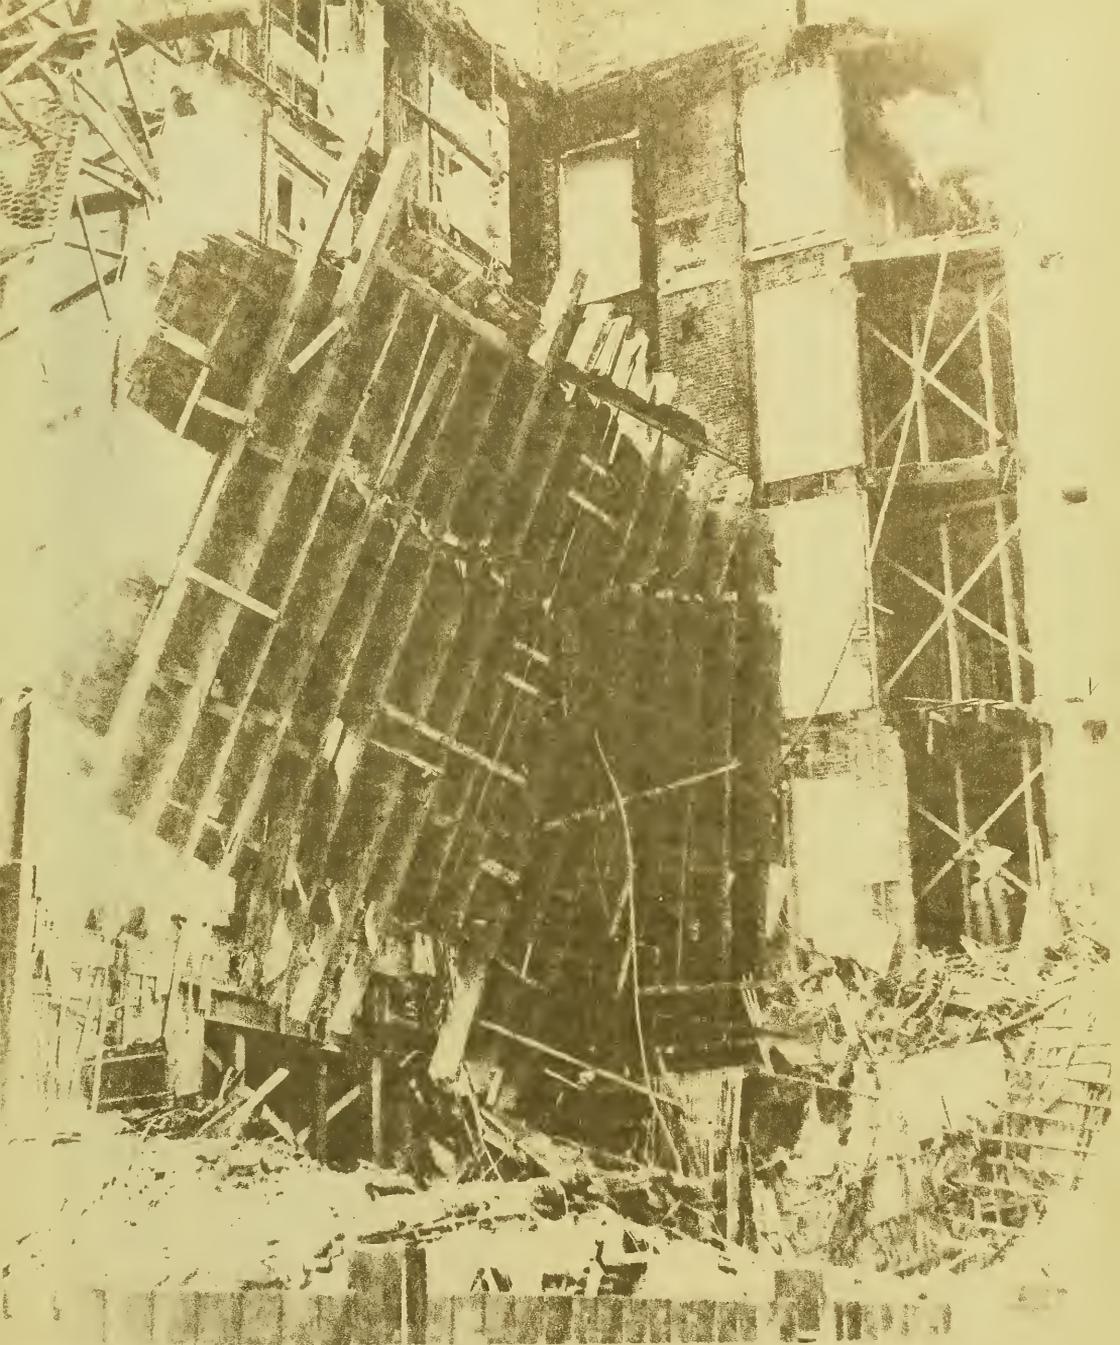
Photo No. 6A

FLOOR SECTIONS BEING REMOVED

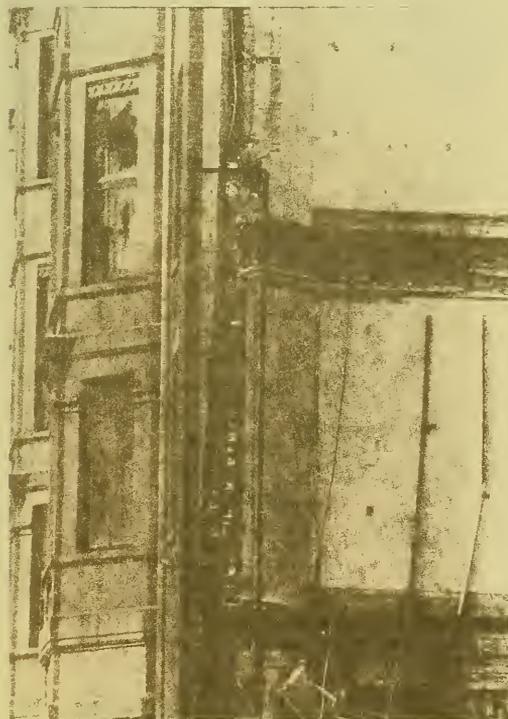
Photo No. 8

E-LINE WALL AT THIRD STORY

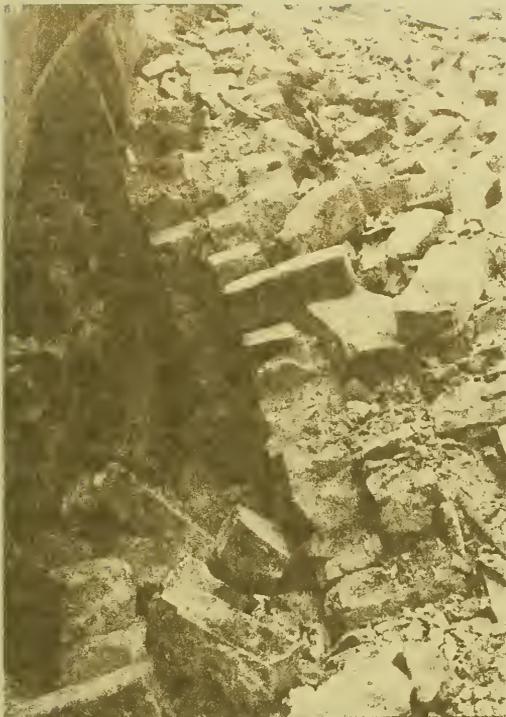
Photo No. 9

collapsed wall originally near ground level were found relatively intact lying against Ladder Truck 15 which was positioned in the alley about three feet from the original wall. (See Photo Nos. 9 and 9A).

LOWER PORTIONS OF E-LINE WALL
LAYING AGAINST LADDER TRUCK 15

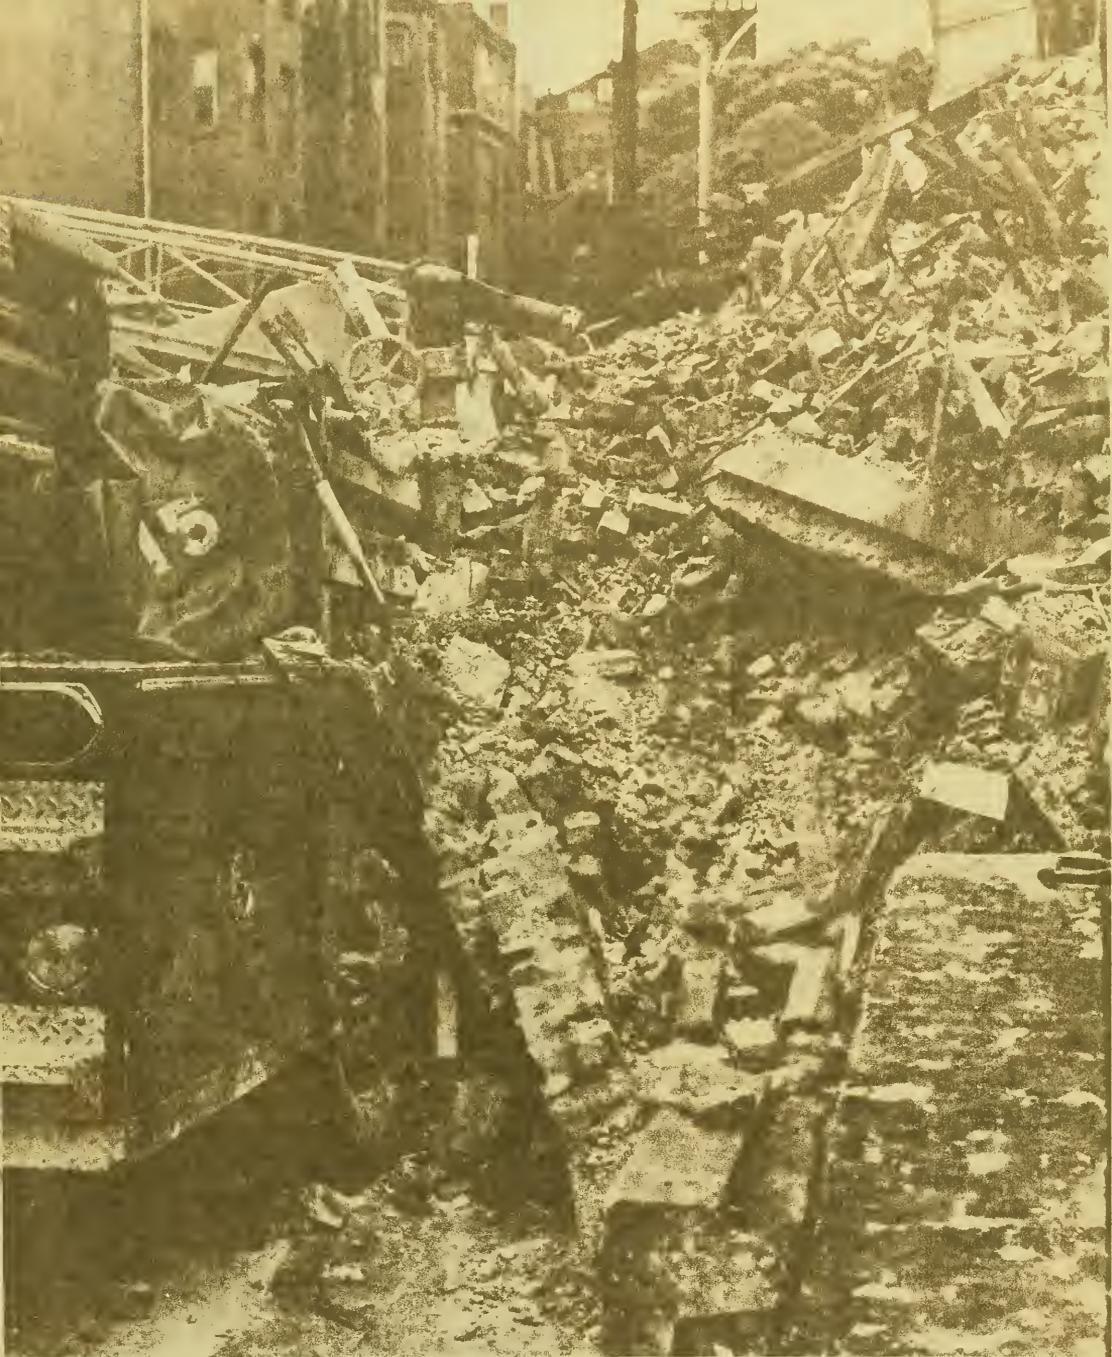
Photo No. 9A

LOWER PORTIONS OF E-LINE WALL LYING
AGAINST LADDER TRUCK 15

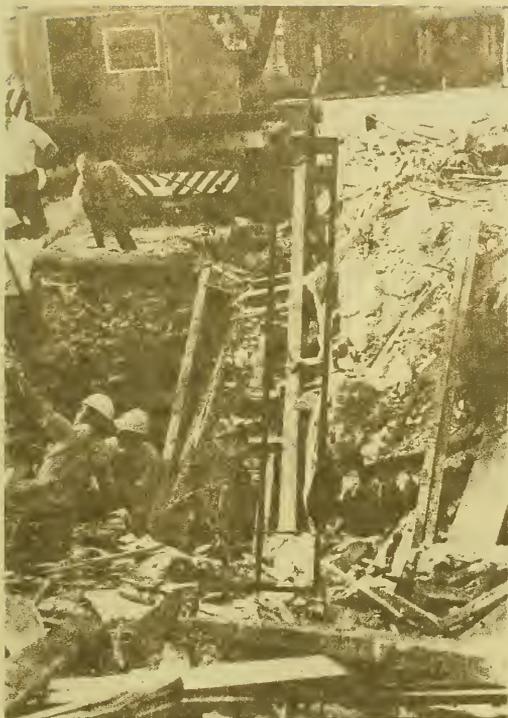
Photo No. 12

SINGLE BEAM LAYING ADJACENT
TO LINE 2 BETWEEN C-LINE AND
E-LINE

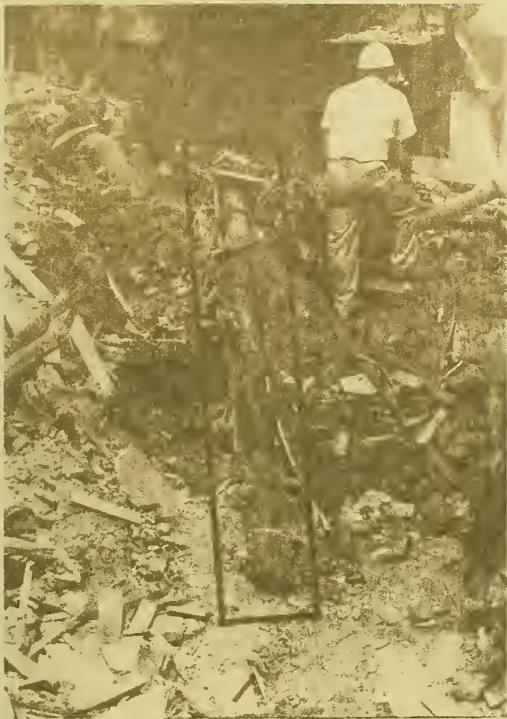
Photo No. 15

COLUMN LAYING NEAR LINE 2
BETWEEN C-LINE AND D-LINE.
BOTTOM PORTION AT BASEMENT
FLOOR

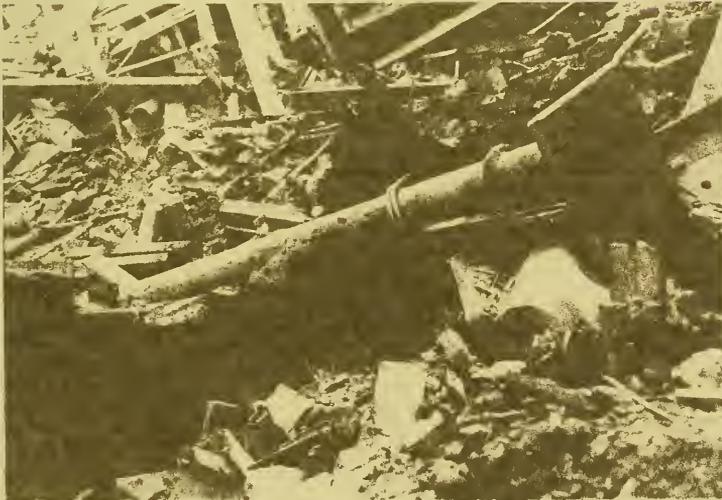
Photo No. 16

TOP PORTION OF
COLUMN LAYING
ACROSS C-LINE
WALL

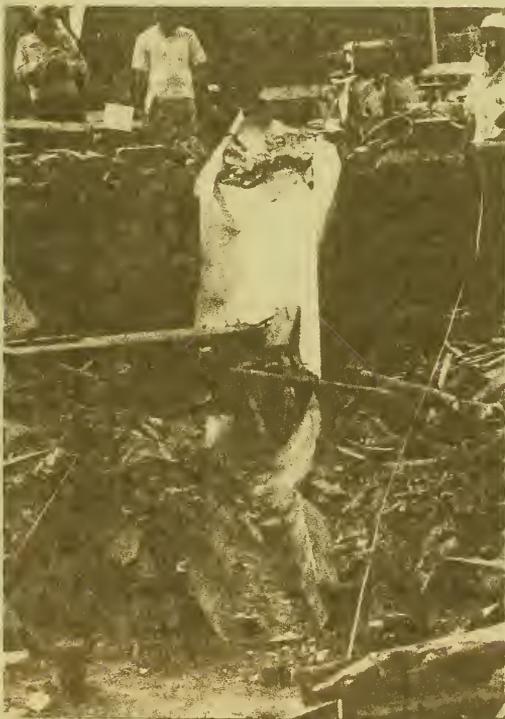
Photo No. 19

SHEET METAL DUCT AT E-LINE
WALL

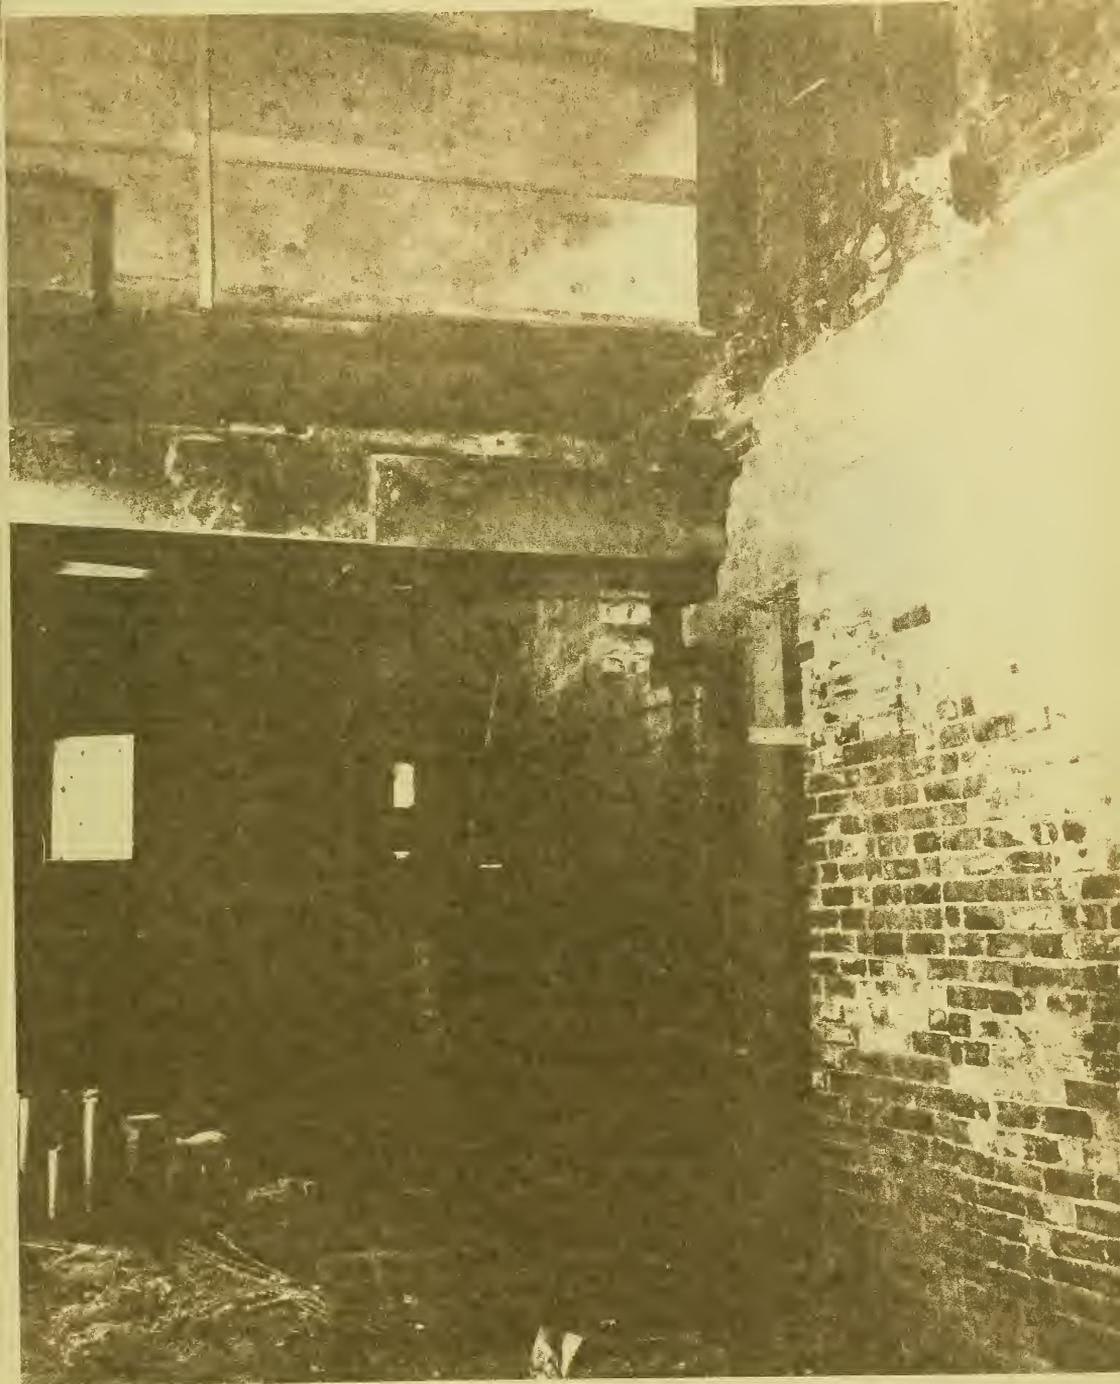
Photo No. 19A

SHEET METAL DUCT PASSING THROUGH B-LINE WALL
(PHOTO TAKEN SOMETIME BEFORE COLLAPSE)

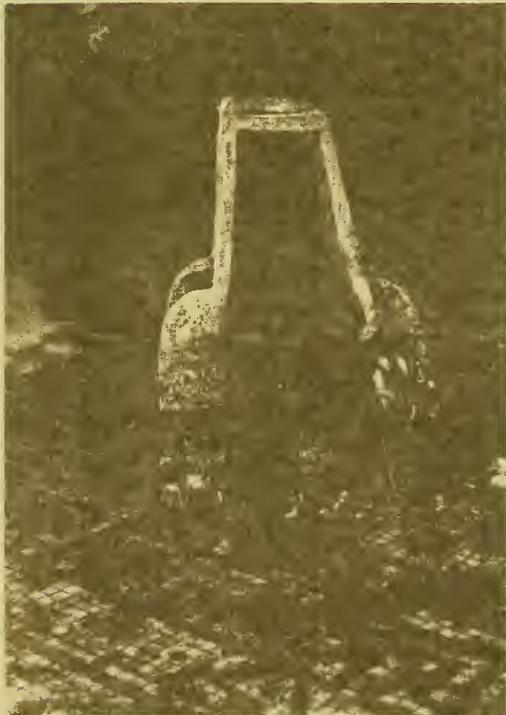
Photo No. 22

SADDLE USED TO SUPPORT 12-INCH
BEAMS FROM 10-INCH BEAM (AT
LINE 2 AND D-LINE)

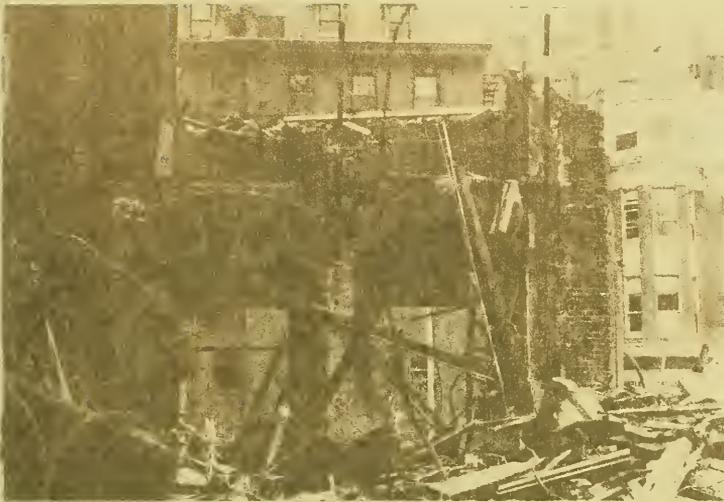
Photo No. 23

WALL POCKETS IN
LINE 3 WALL FOR
C-LINE AND D-
LINE BEAMS

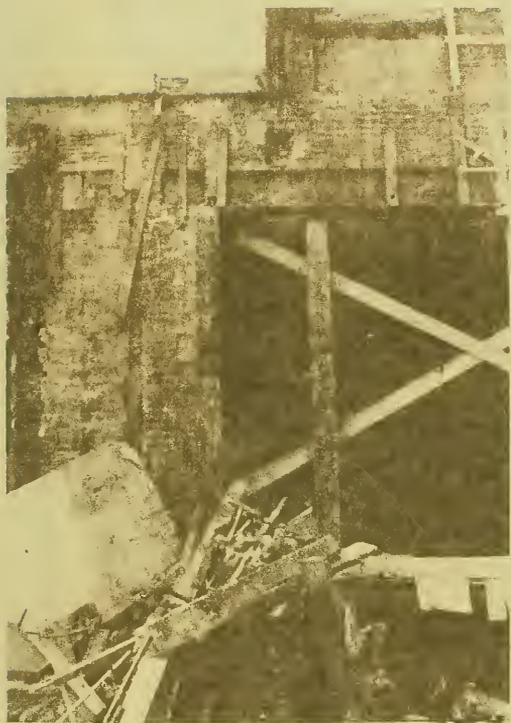
Photo No. 25

SUPPORT AT LINE 1 WALL FOR
D-LINE BEAM

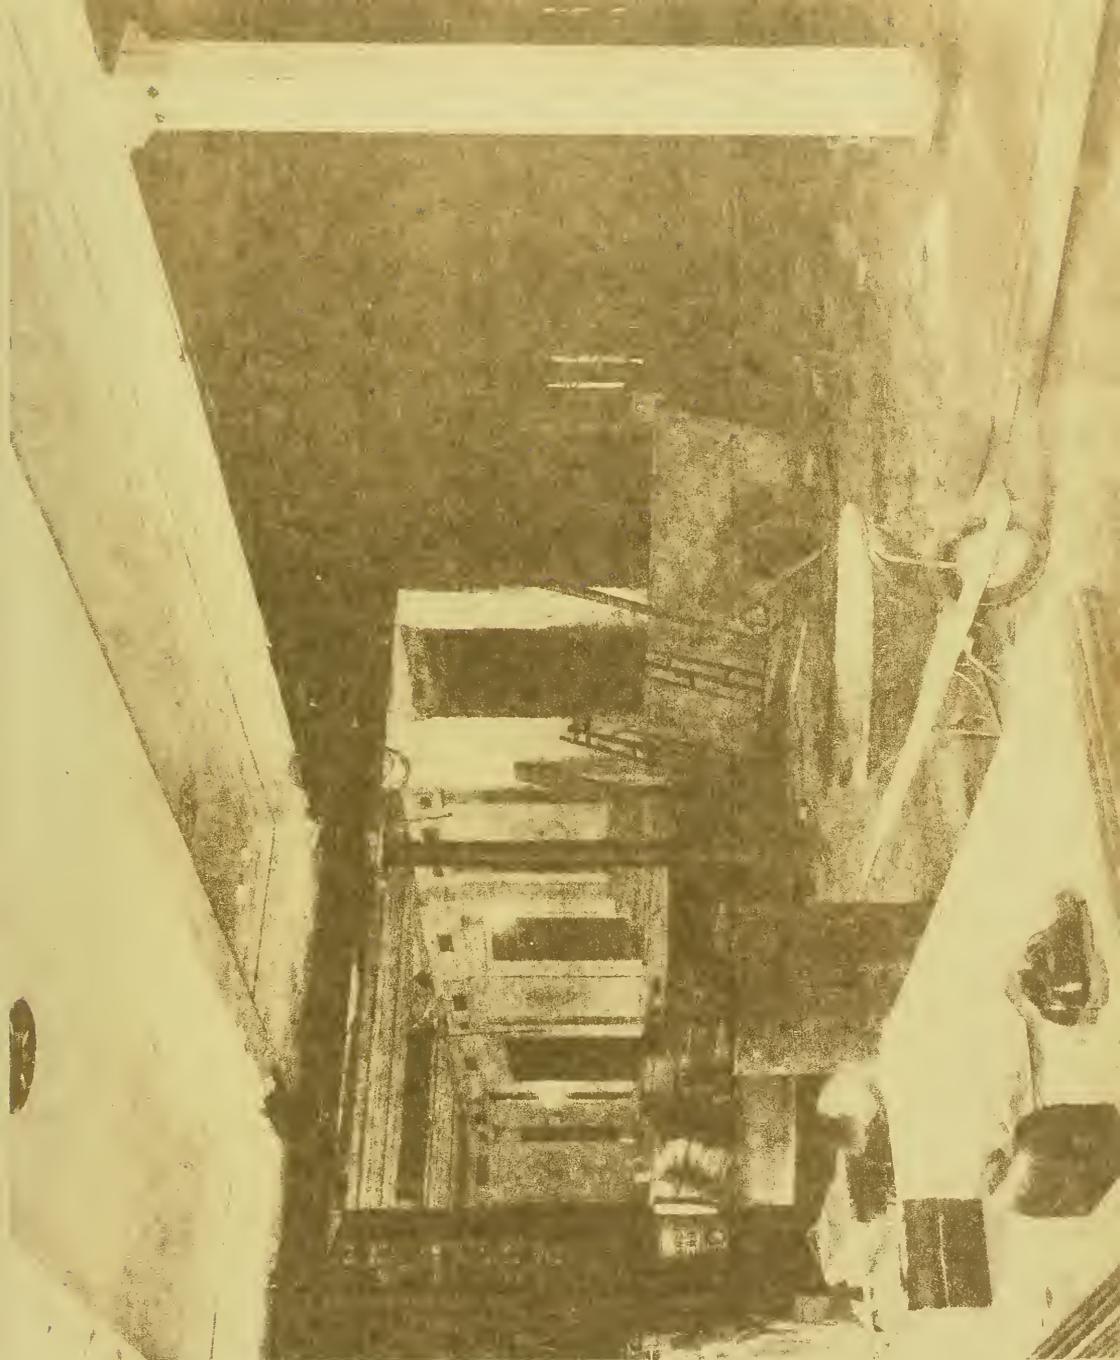
Photo No. 25A

10-inch wrought iron beam, had two single 12-inch wrought iron beams suspended from it, all of which formed a part of the second floor framing system. Thus, the 7-inch cast iron column was the main support of the bearing wall above the second floor with the addition of at least half of the second floor load in the area. The base plate of this column was positioned on the wall along the C-Line approximately at the first floor level.

COLUMN AND PORTIONS OF C-LINE AND D-LINE BEAMS
(PHOTO TAKEN SOMETIME BEFORE COLLAPSE)
