CITY OF BOSTON

REPORT
OF
INVESTIGATION OF COLLAPSE
AT
HOTEL VENDOME

AUGUST, 1972

CHAS. T. MAIN, INC.
Engineers

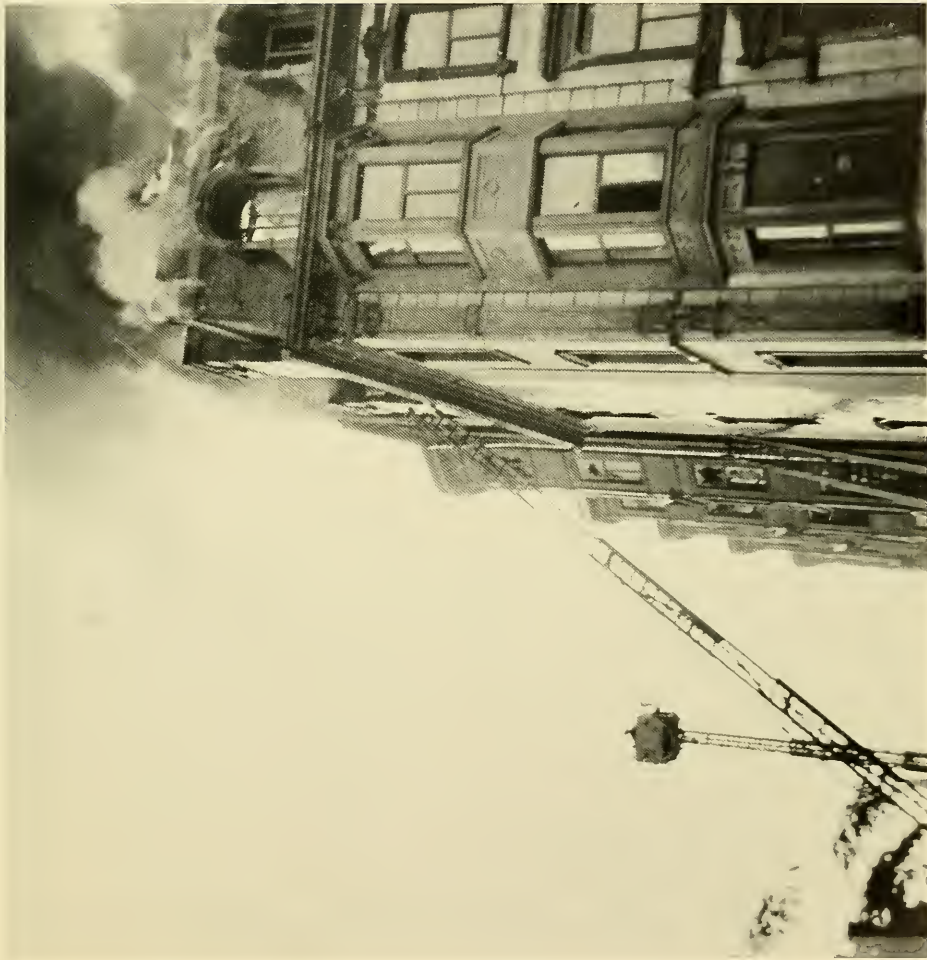
NO. 39
SOUTHEAST CORNER BEFORE COLLAPSE—
NOTE INTENSE FIRE IN ROOF STRUCTURE.
PHOTOGRAPH TAKEN BY JAMES B. FORGIE

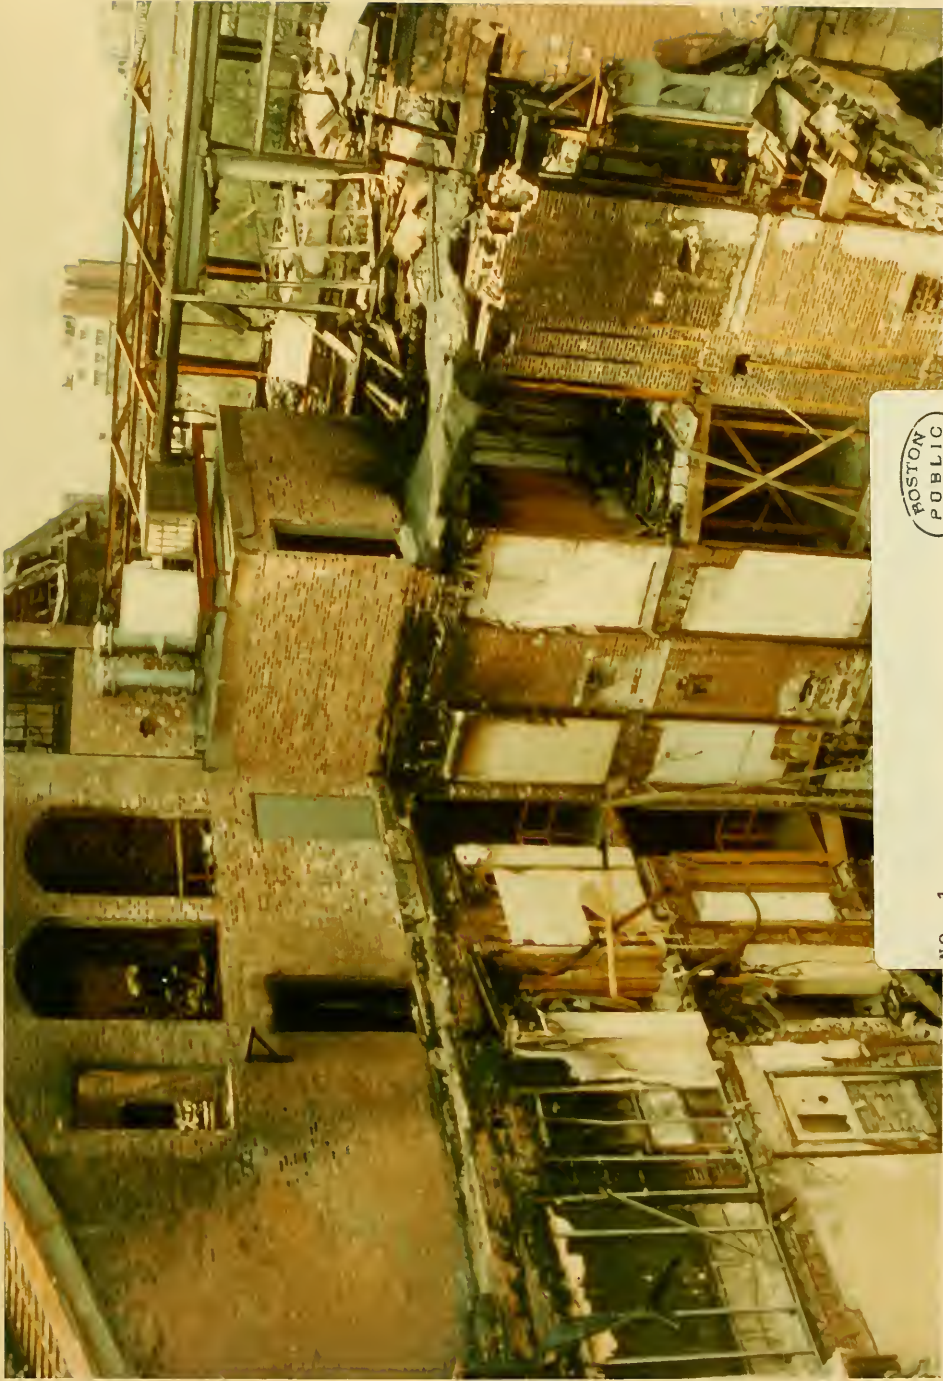
NO. 1
GENERAL VIEW
UPPER SECTION OF COLLAPSE AREA

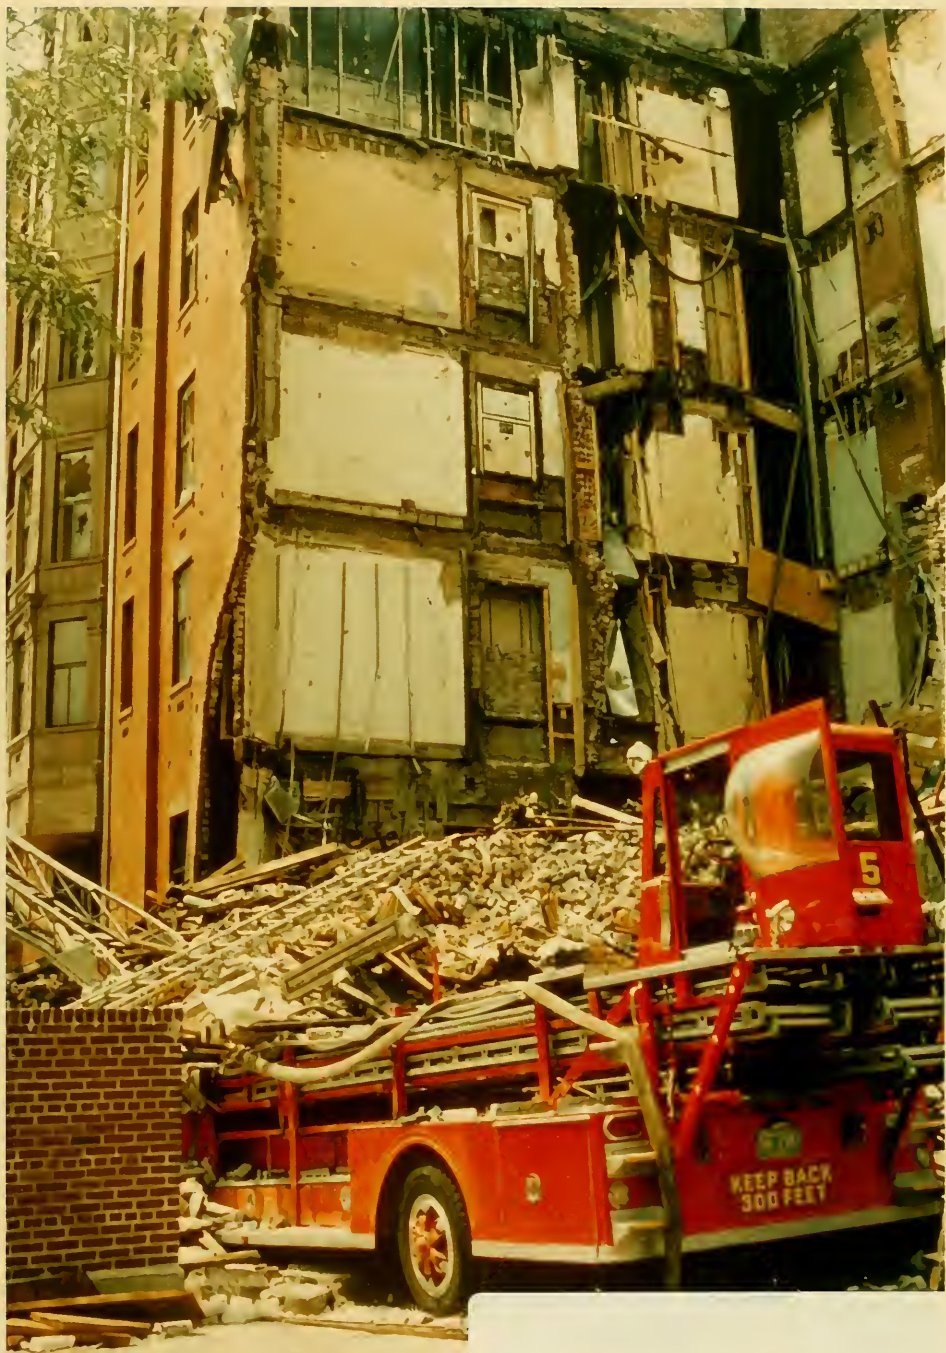
NO. 2
VIEW OF REMAINING WEST WALL

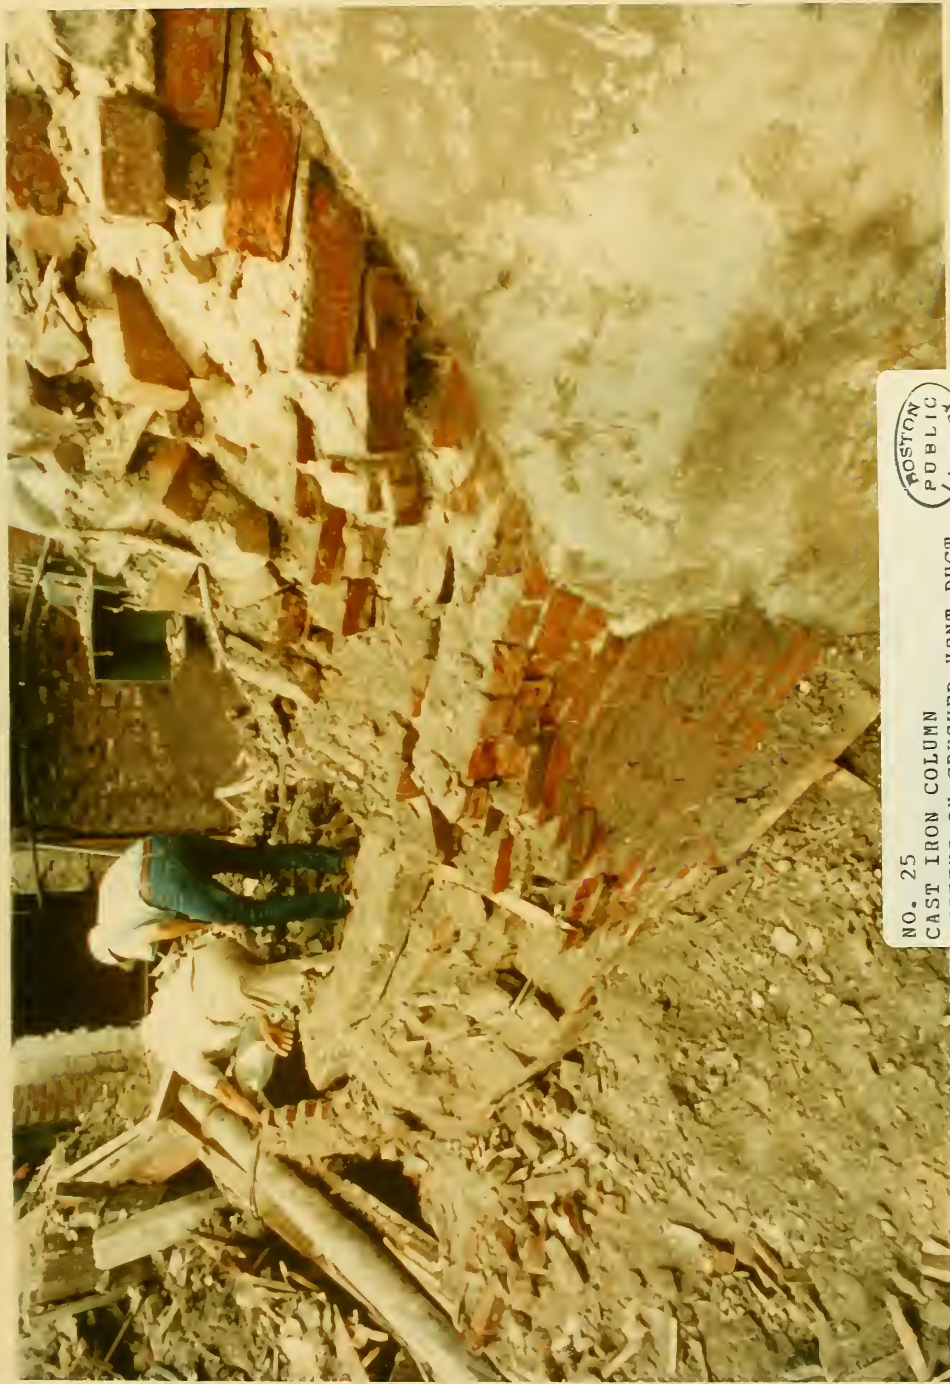
NO. 25

CAST IRON COLUMN
RESTING ON CRUSHED VENT DUCT
IN DOOR OPENING—

NOTE GRANITE BLOCK BEYOND—
NOTE CONDITION OF CENTRAL BEARING WALL.

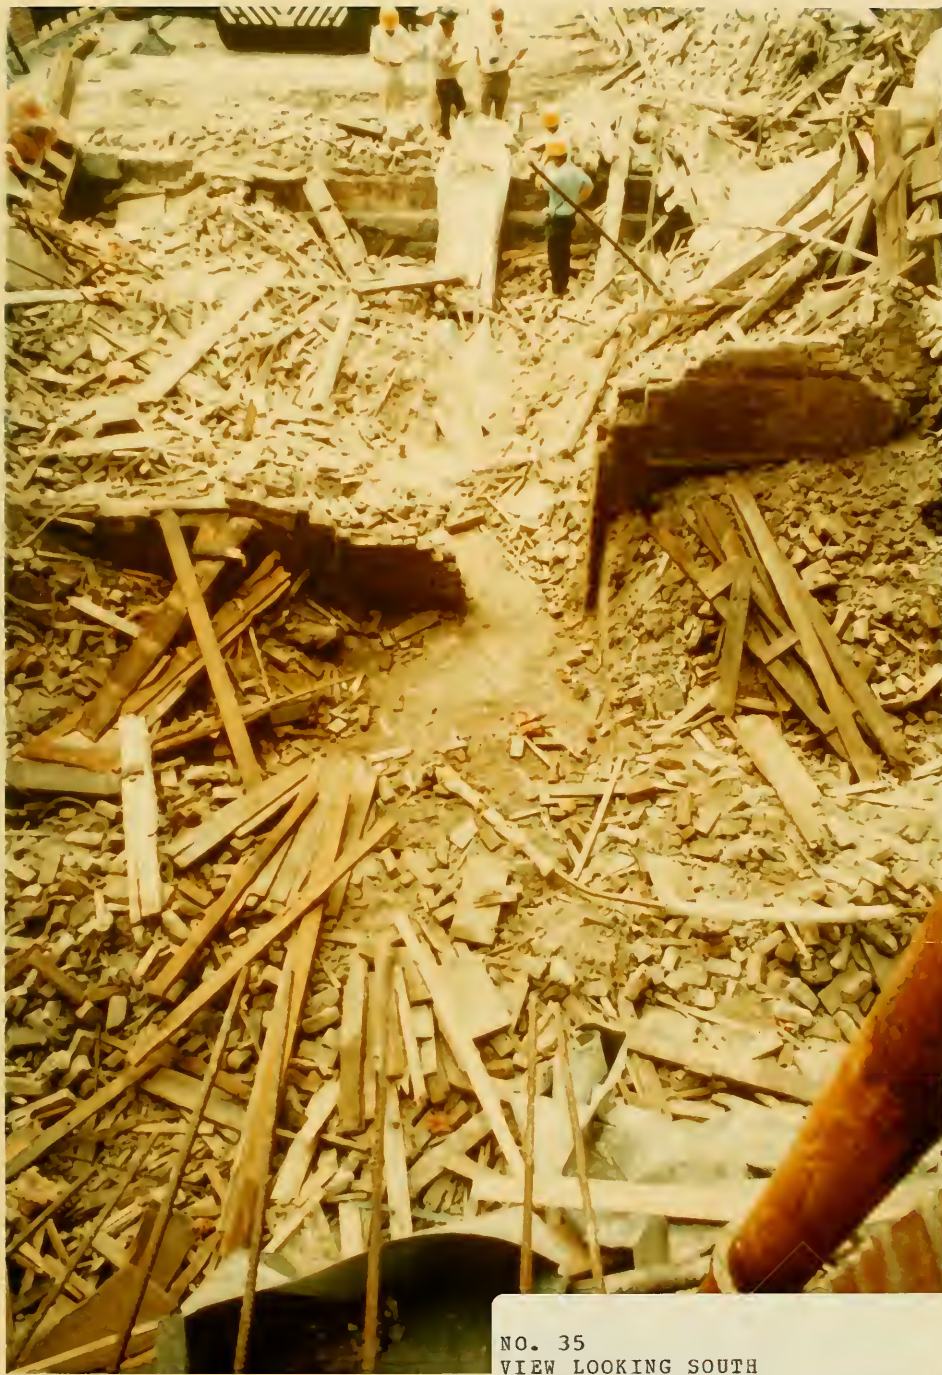
Following removal of all floors and nearly all of the debris a ventilation duct 12" x 30" was exposed in the Basement. All sections of the duct were found and measured. The duct was made of straight sections except for an offset at the south wall to meet a wall louver. Measurement of strap hangers found on the duct and measurements at the north wall showed that the duct had been approximately eight inches below the floor joists.

NO. 35
VIEW LOOKING SOUTH
AT COMPLETION OF SITE INVESTIGATION-
NEAR AND FAR ENDS OF
BASEMENT VENT DUCT SHOWN.

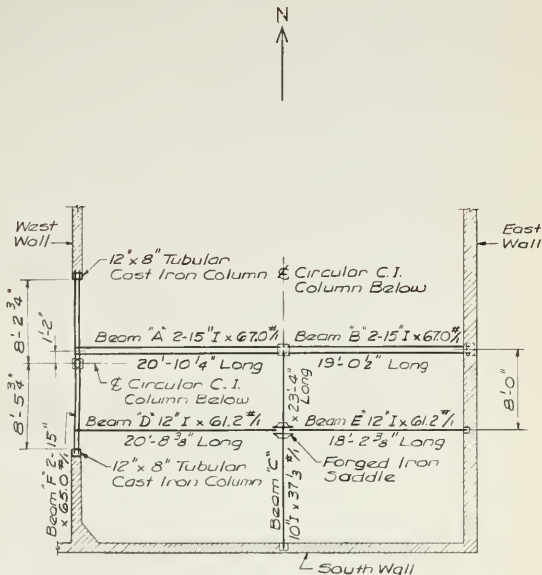
PLAN
RECONSTRUCTION OF 2ND FLOOR
SUPPORT FRAMING

Drawing R3 shows a plan view of this framing as reconstructed with data shown for the various beams.

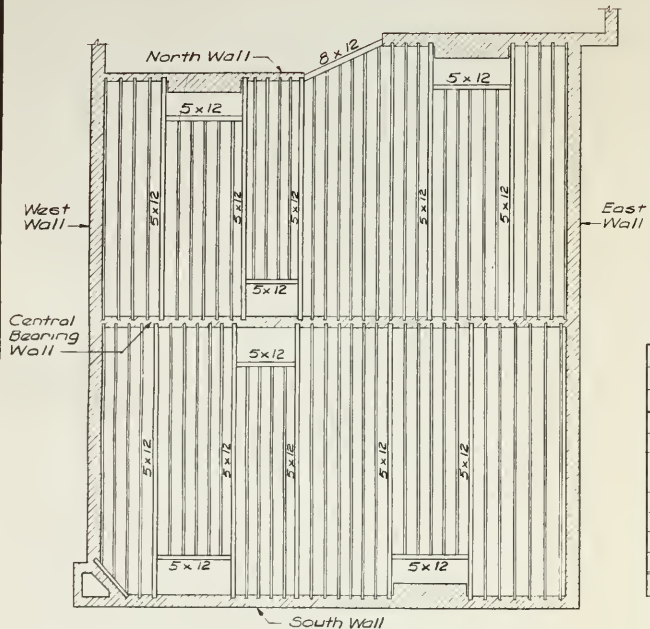
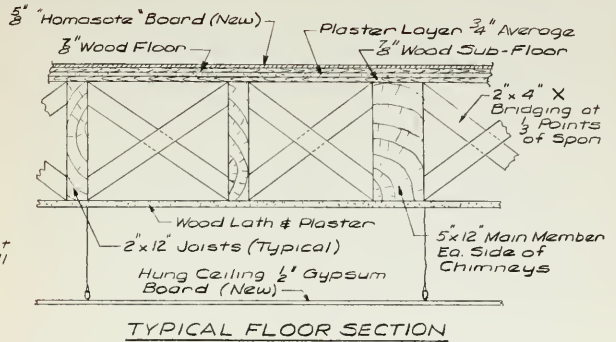
FRAMING PLAN - 5TH FLOOR
3RD & 4TH FLOORS SAME
 All Floor Joists 2" x 12" Except as Noted

FLOOR		ROOF	
ESTIMATE OF DEAD WEIGHTS		ESTIMATE OF DEAD WEIGHTS	
MATERIAL	WEIGHT PER SQUARE FT.	MATERIAL	WEIGHT PER SQUARE FT.
5/8" Homasote Board	2.0	Roofing Tar & Felts	4.0
3/8" Wood Floor	4.0	Quarry Tile	15.0
Plaster Fill	8.0	Concrete Fill	56.0
Wood Sub-Floor	3.0	Wood Deck	4.0
Wood Joists	5.0	Wood Joists	5.0
Misc. Piping & Wiring	2.0	Misc. Piping & Wiring	2.0
Existing Plaster Ceiling	8.0	Existing Plaster Ceiling	8.0
New Gypsum Ceiling	8.0	New Gypsum Ceiling	8.0
TOTAL	40.0 #/ft²	TOTAL	102.0 #/ft²

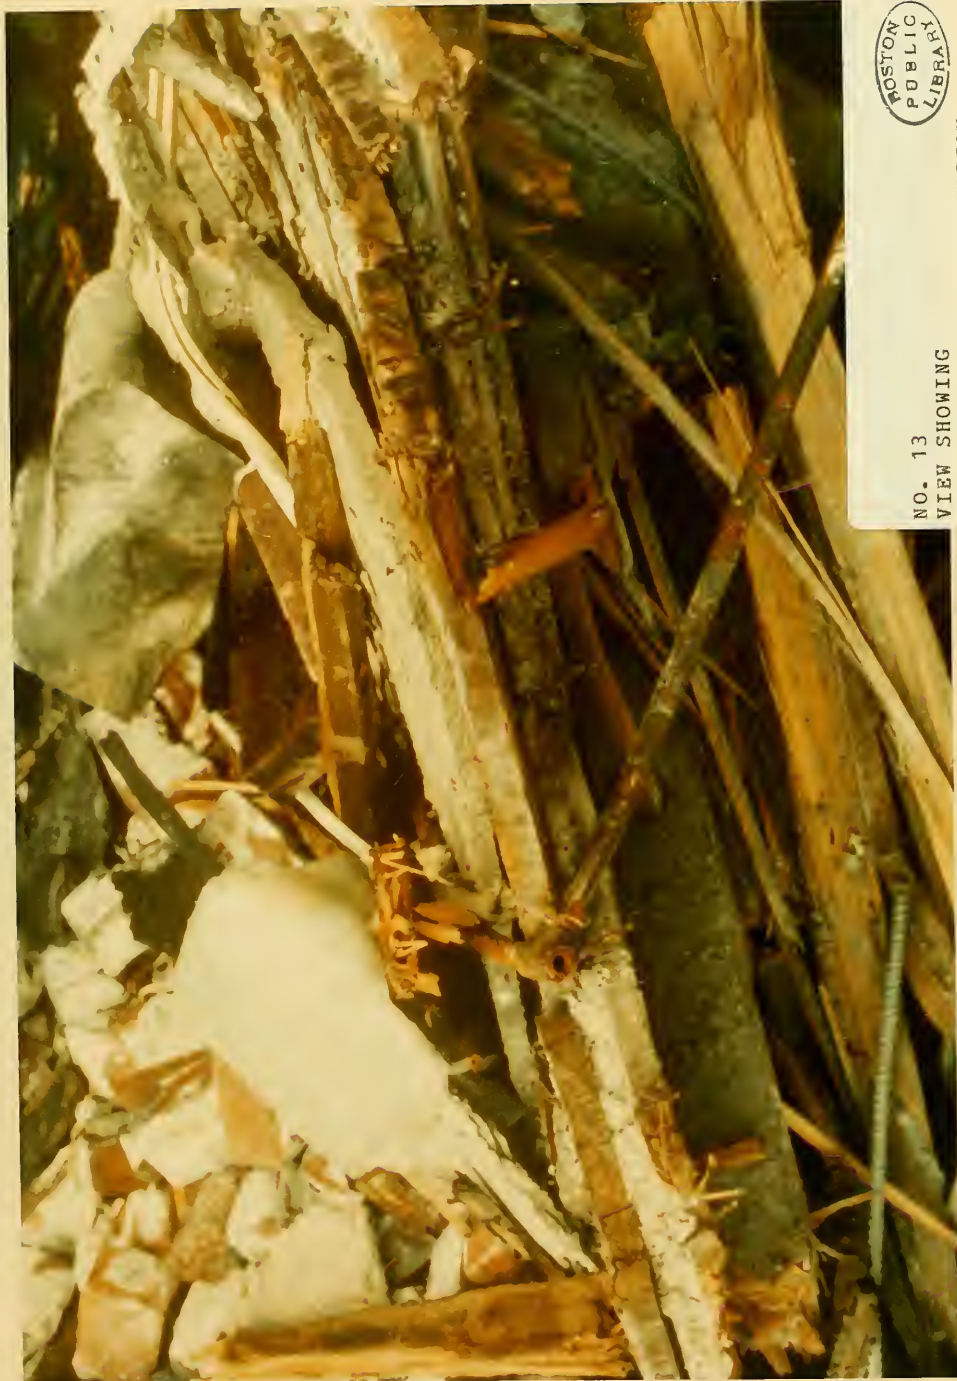
NO. 13

VIEW SHOWING
LAMINATED FLOOR CONSTRUCTION

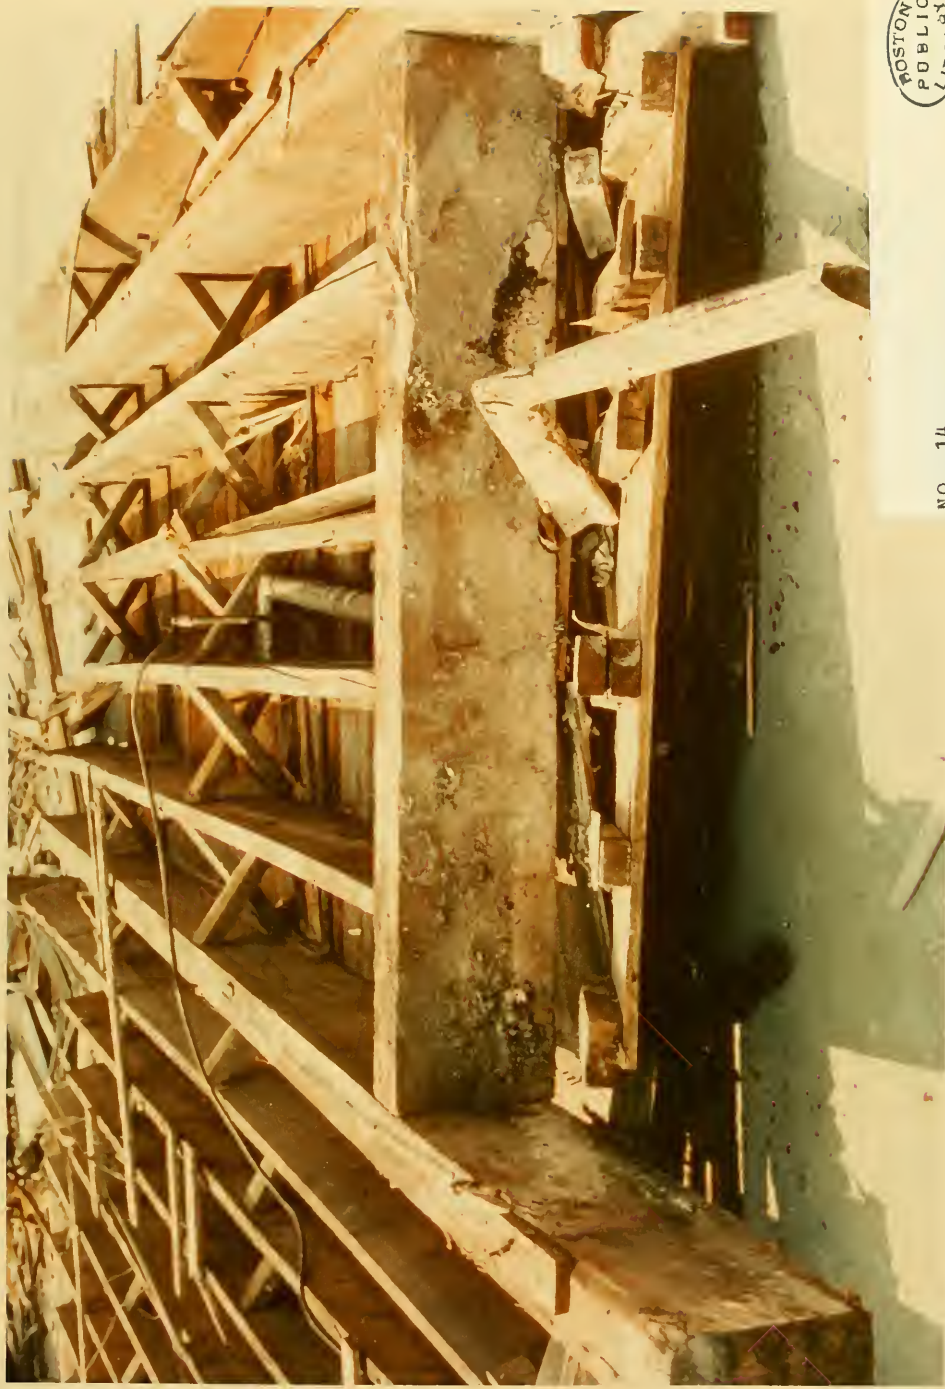
NO. 14
VIEW OF 5TH FLOOR
INVERTED, RESTING IN PARKING LOT.

At 3:00 P.M. a large section of the fifth floor was lifted out and laid down in the parking lot in an inverted position. This section lifted cleanly away from the lath and plaster ceiling, leaving it resting intact against the fourth floor. The floor framing appeared to conform very well with the original plans. The major beams (5" x 12") showed minor checking, but the joists (2" x 12") showed no checking. The floor framing appeared quite sound; most damage occurred from the distortions caused from lifting it as a unit.

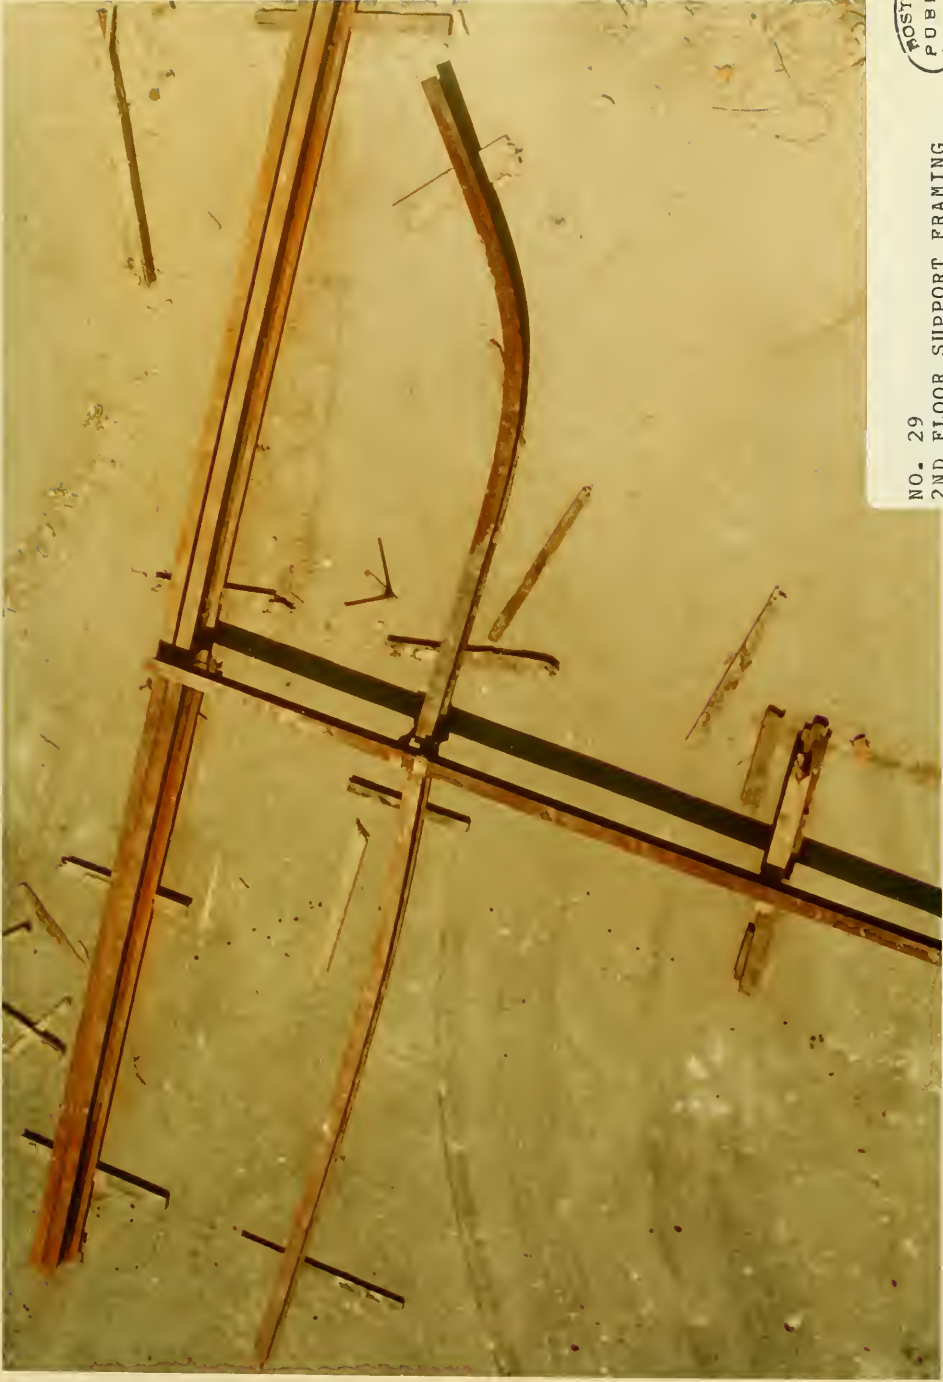
NO. 29

2ND FLOOR SUPPORT FRAMING
RE-ASSEMBLED IN PARKING LOT-
AS PHOTOGRAPHED FROM BUCKET ON CRANE.

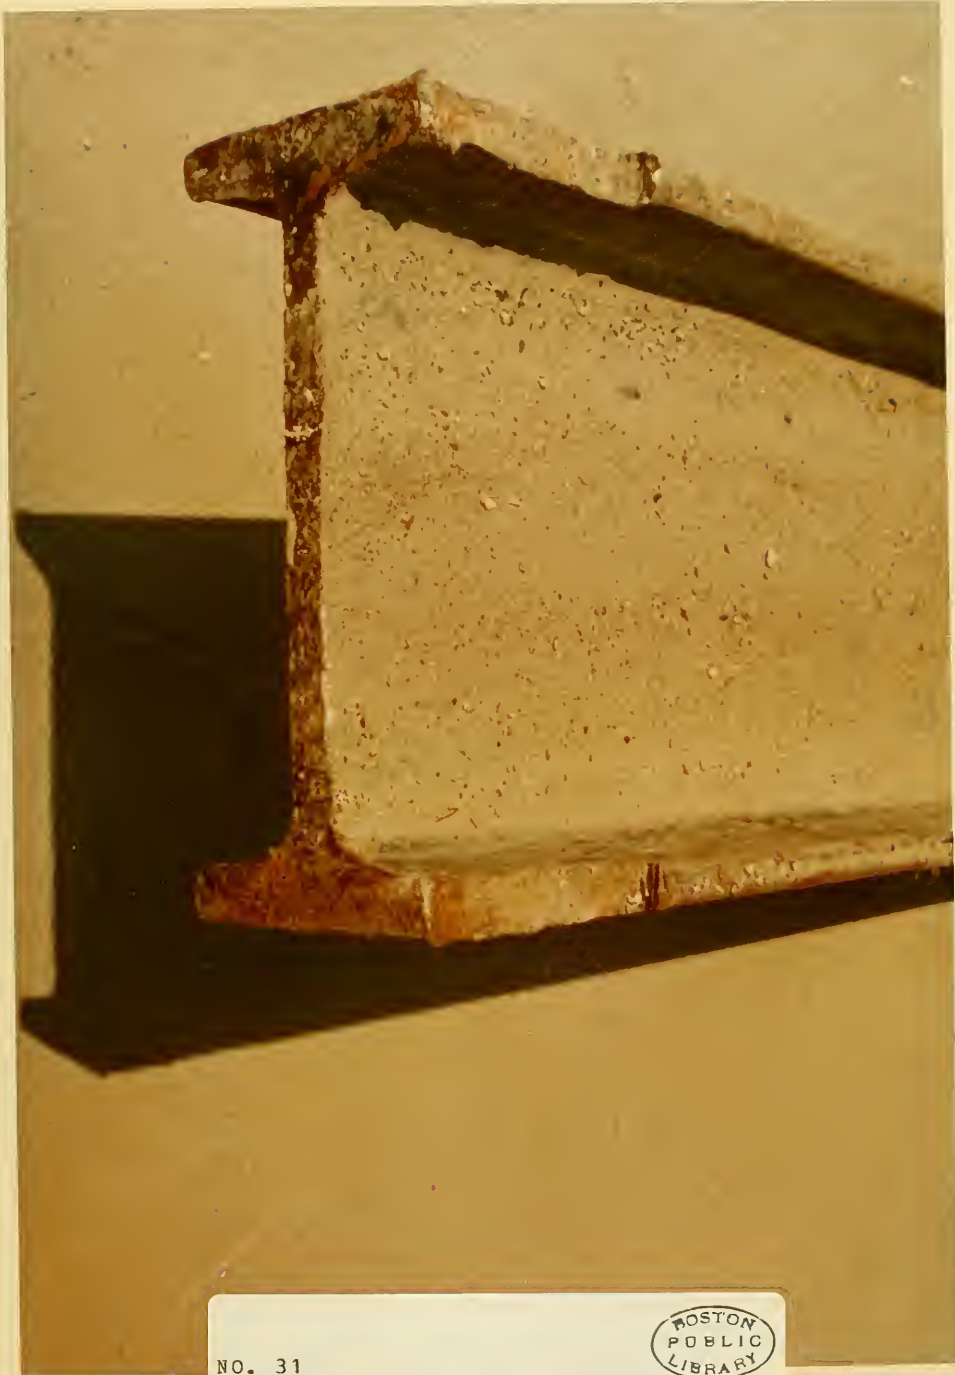
NO. 31

END OF 12 I BEAM ('D' OR 'E') -

NOTE FLANGE CUT TO FIT IRON SADDLE.

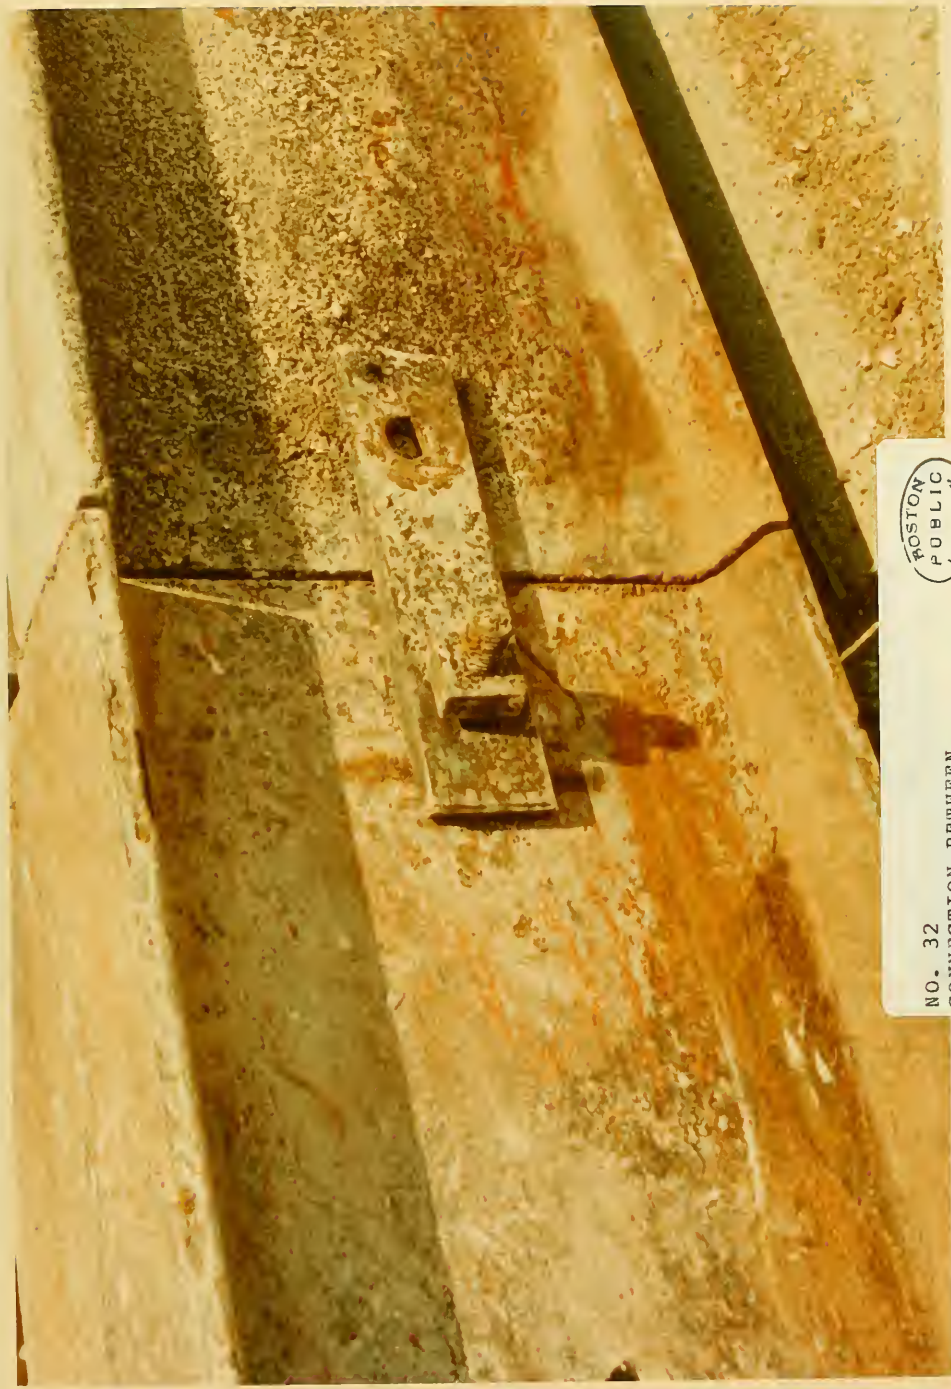
NO. 32

CONNECTION BETWEEN
DOUBLE I BEAMS 'A' AND 'B'
CAST IRON COLUMN
WAS DIRECTLY BELOW THIS POINT.

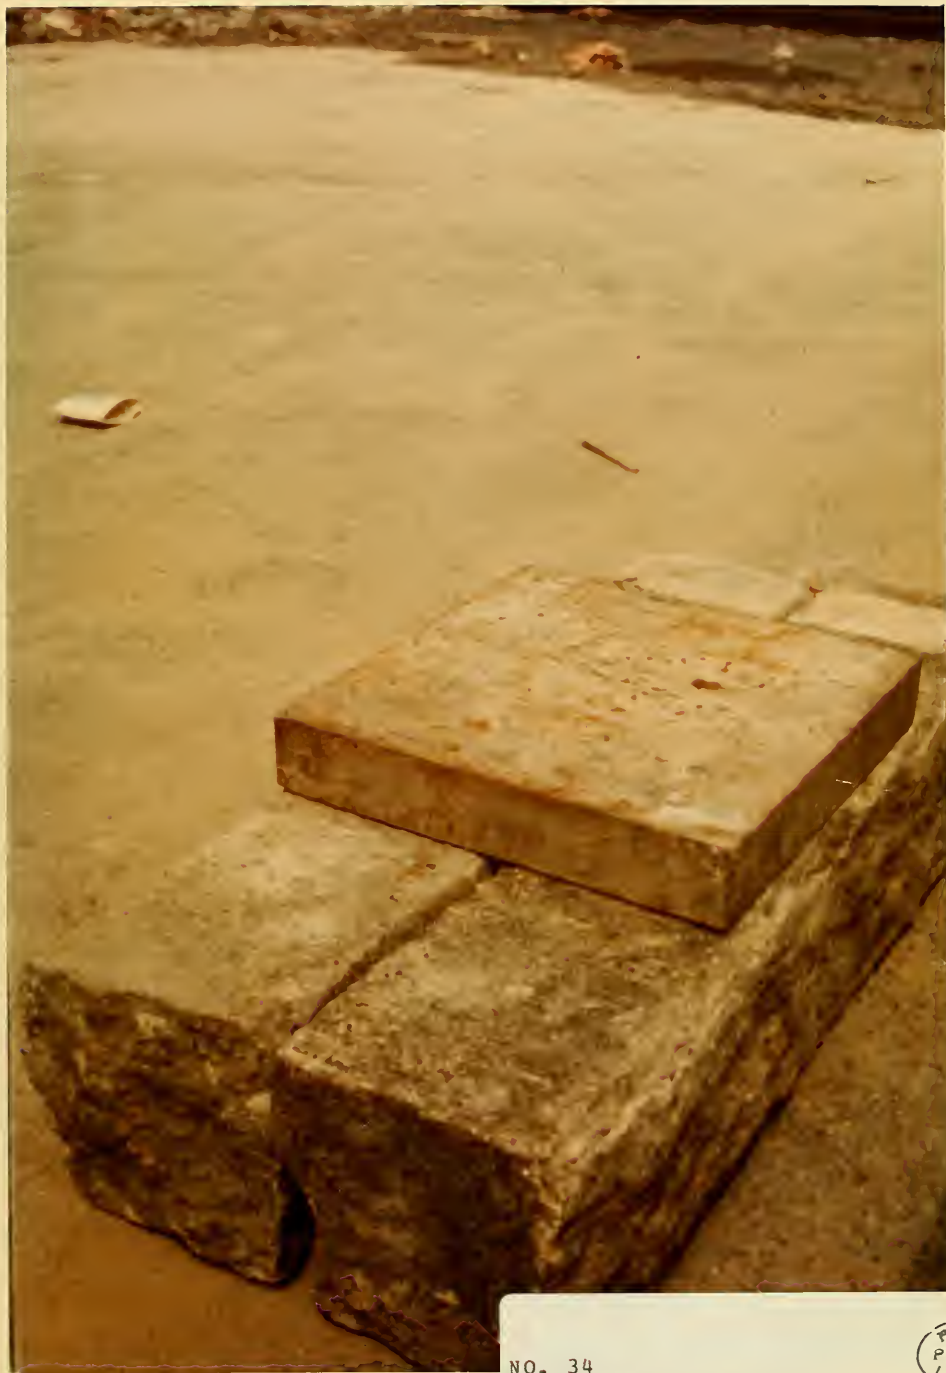
NO. 34

END VIEW OF BASEPLATE AND
BEARING BLOCKS (RE-ASSEMBLED)

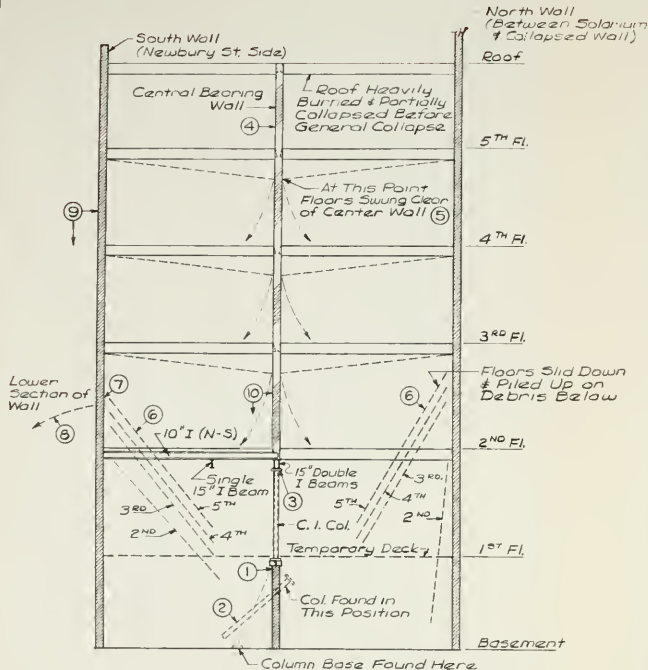
SEQUENCE OF COLLAPSE

It is our opinion that the collapse was initiated by a bearing and/or shear failure of the bearing wall under a single central column between the second floor and the first floor (upper concourse level). The failure allowed this cast-iron column to drop to the basement level resulting in a complete collapse of the upper floors. (See R5 and R6.)

- 1 Bearing Wall Fails Under Central Column
- 2 Column Falls into Basement
- 3 15" Double I Beams Drop in Center and Rotate Out of End Bearings.
- 4 Central Wall Starts Dropping.
- 5 When Central Wall Drops Two Feet, Floor Systems Slip Free.
- 6 Floor Systems Swing Against Walls, Break Free and Slide into Basement.
- 7 Floor Systems Lie Against Newbury Street Wall.
- 8 Lower Portion of Newbury Street Wall Gives Way Under Pressure From Floors. Rotates Outward, Burying Fire Engine.
- 9 Upper Part of Newbury Street Wall Collapses on Top of Debris.
- 10 Meanwhile, Central Wall Has Fallen into Basement Along With Fragments of Roof.

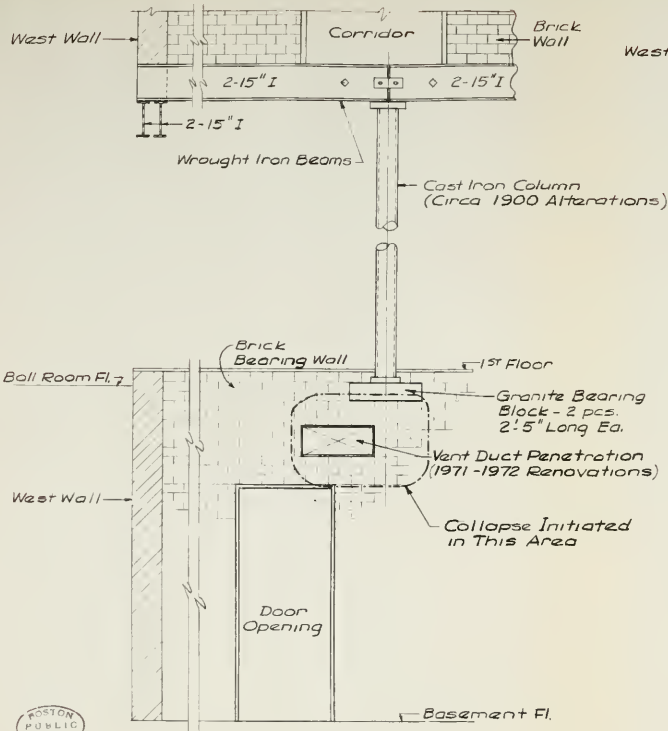
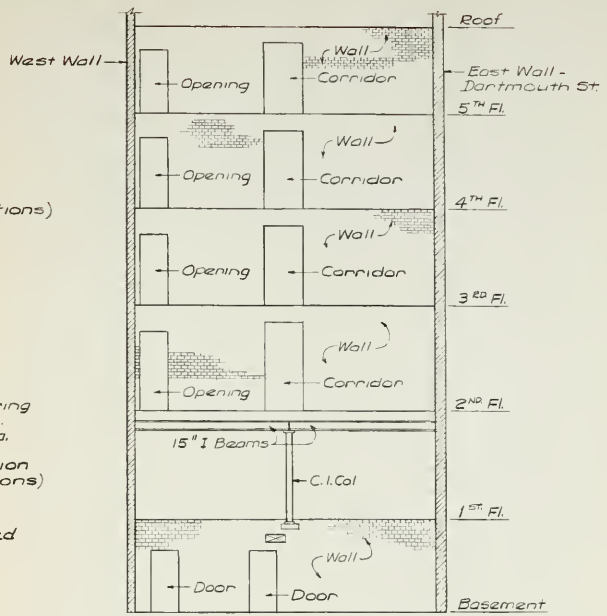
ELEVATION OF CENTER BEARING WALLS
(Immediately Prior to Collapse)

We believe that the collapse of the structure was caused by a bearing and/or shear failure of the center masonry bearing wall under the cast-iron column at the first floor (upper concourse level), adjacent to the door and duct opening in the wall. (See R6.)

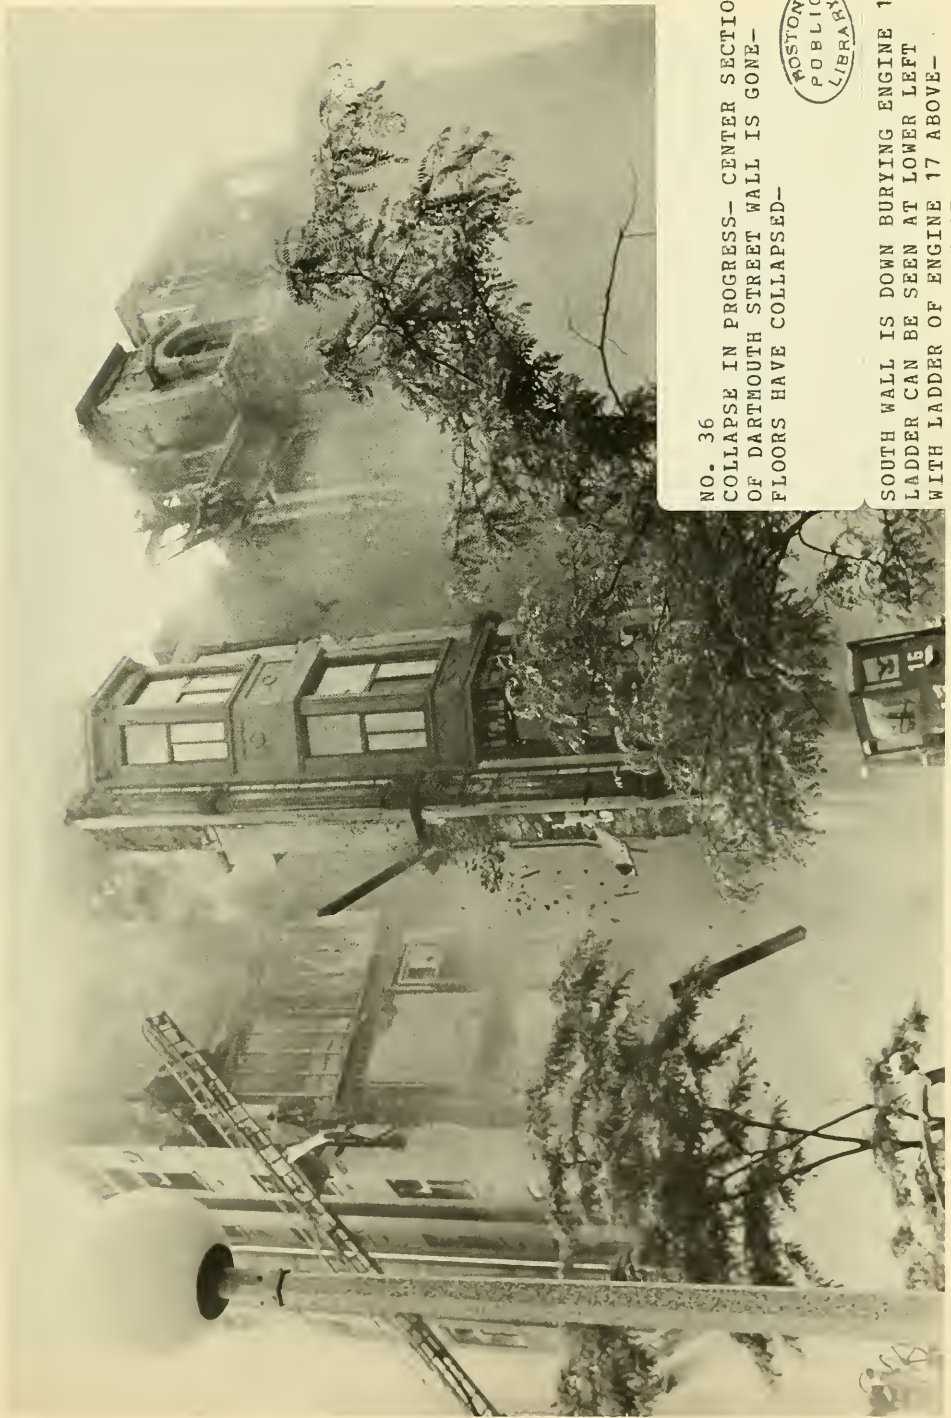
NO. 36

COLLAPSE IN PROGRESS-- CENTER SECTION
OF DARTMOUTH STREET WALL IS GONE--
FLOORS HAVE COLLAPSED--

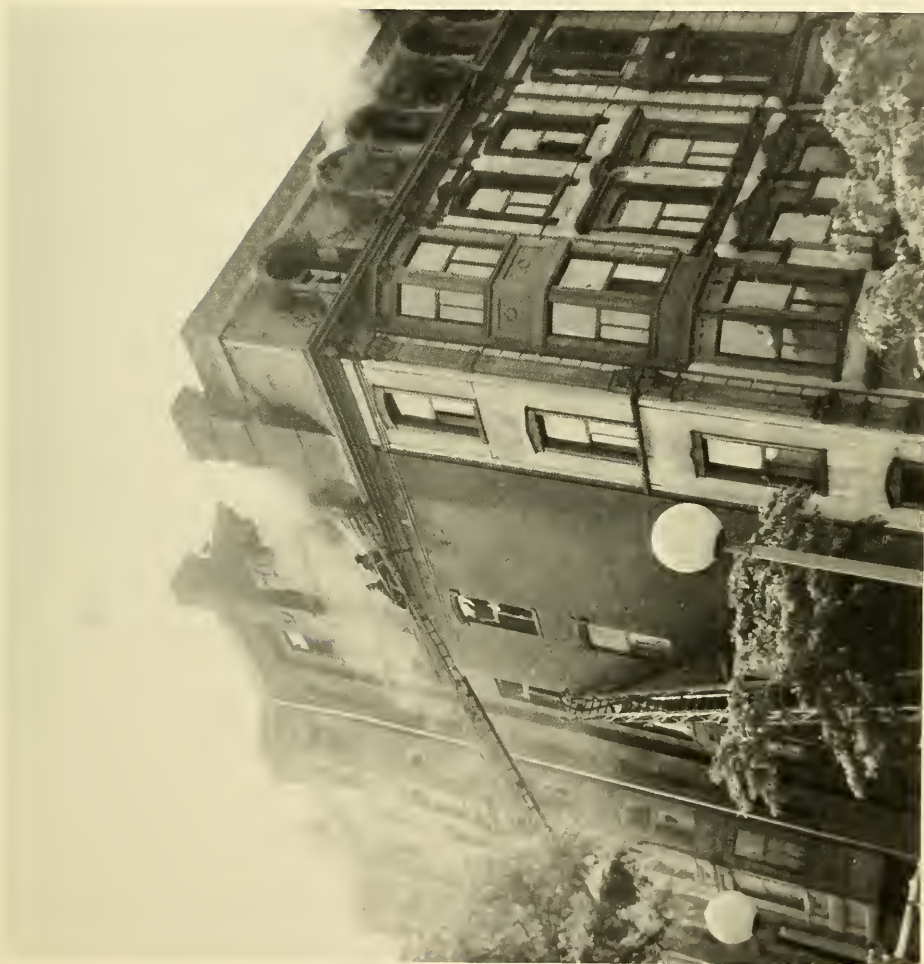
NO. 38
SOUTHEAST CORNER BEFORE COLLAPSE-
NOTE WINDOWS IN SOUTH WALL
BELOW CHIMNEY-
COMPARE THIS PHOTO WITH NO. 36
PHOTOGRAPH TAKEN BY JAMES B. FORGIE

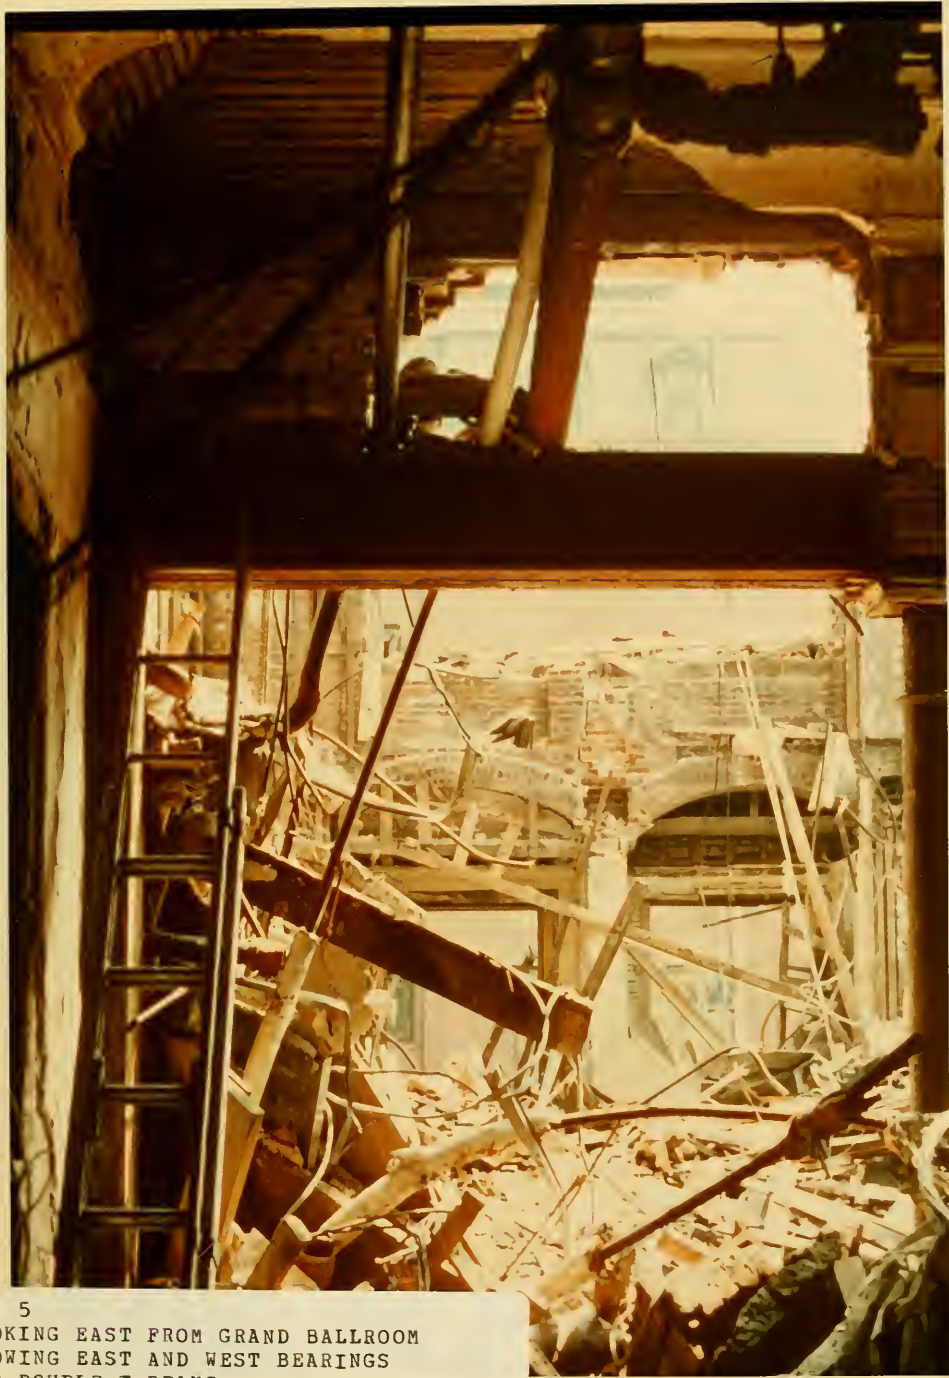
NO. 5
LOOKING EAST FROM GRAND BALLROOM
SHOWING EAST AND WEST BEARINGS
FOR DOUBLE I BEAMS—
END OF DOUBLE I BEAMS 'A'
VISIBLE IN DEBRIS BELOW

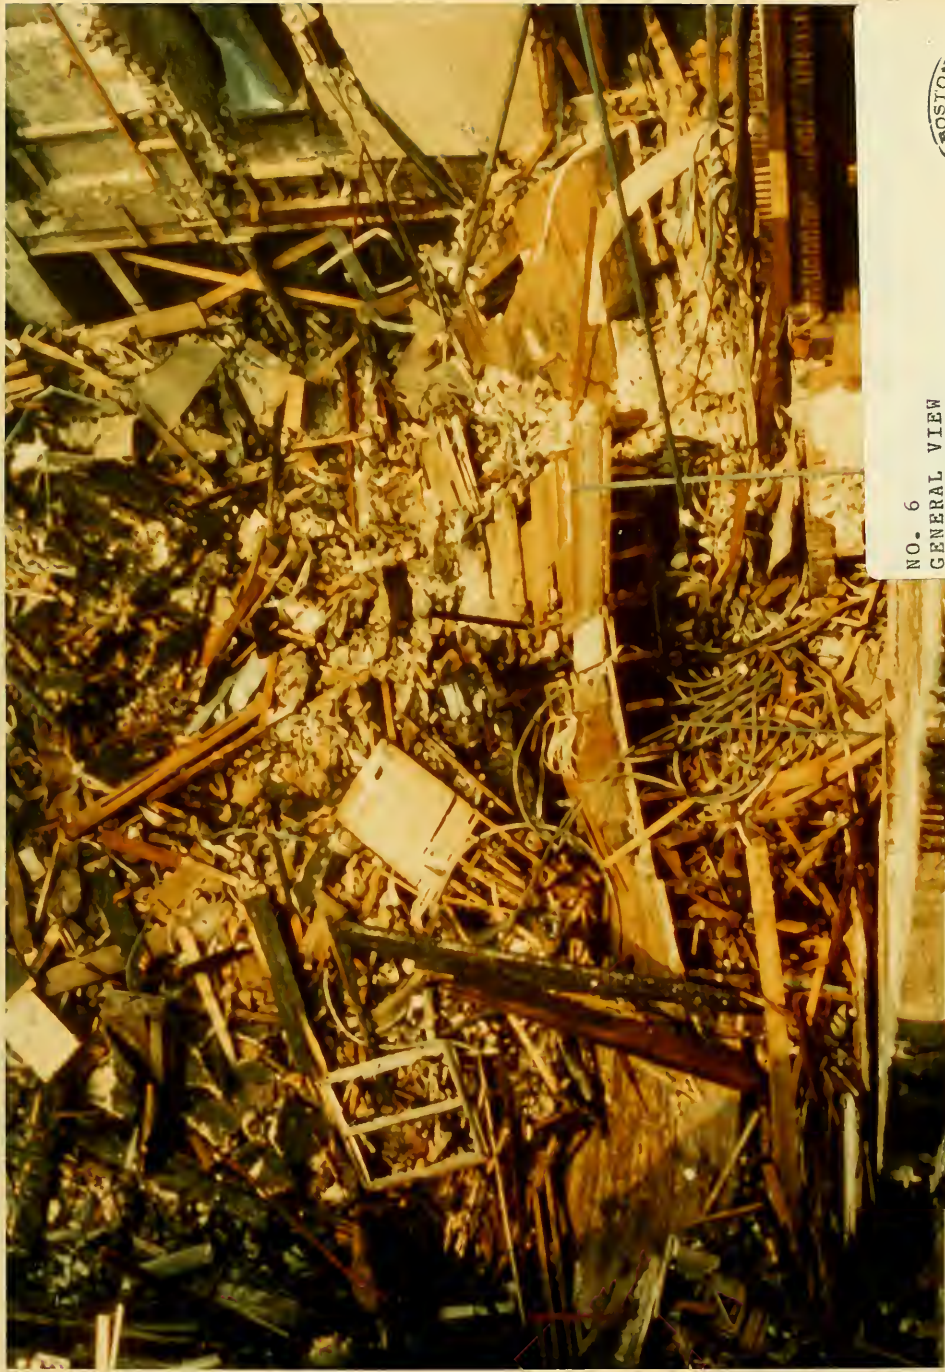
NO. 6
GENERAL VIEW
LOOKING DOWN AT DEBRIS
BEFORE START OF REMOVAL.
