CITY OF BOSTON

REPORT
OF
INVESTIGATION OF COLLAPSE
AT
HOTEL VENDOME

AUGUST, 1972

CHAS. T. MAIN, INC.
Engineers

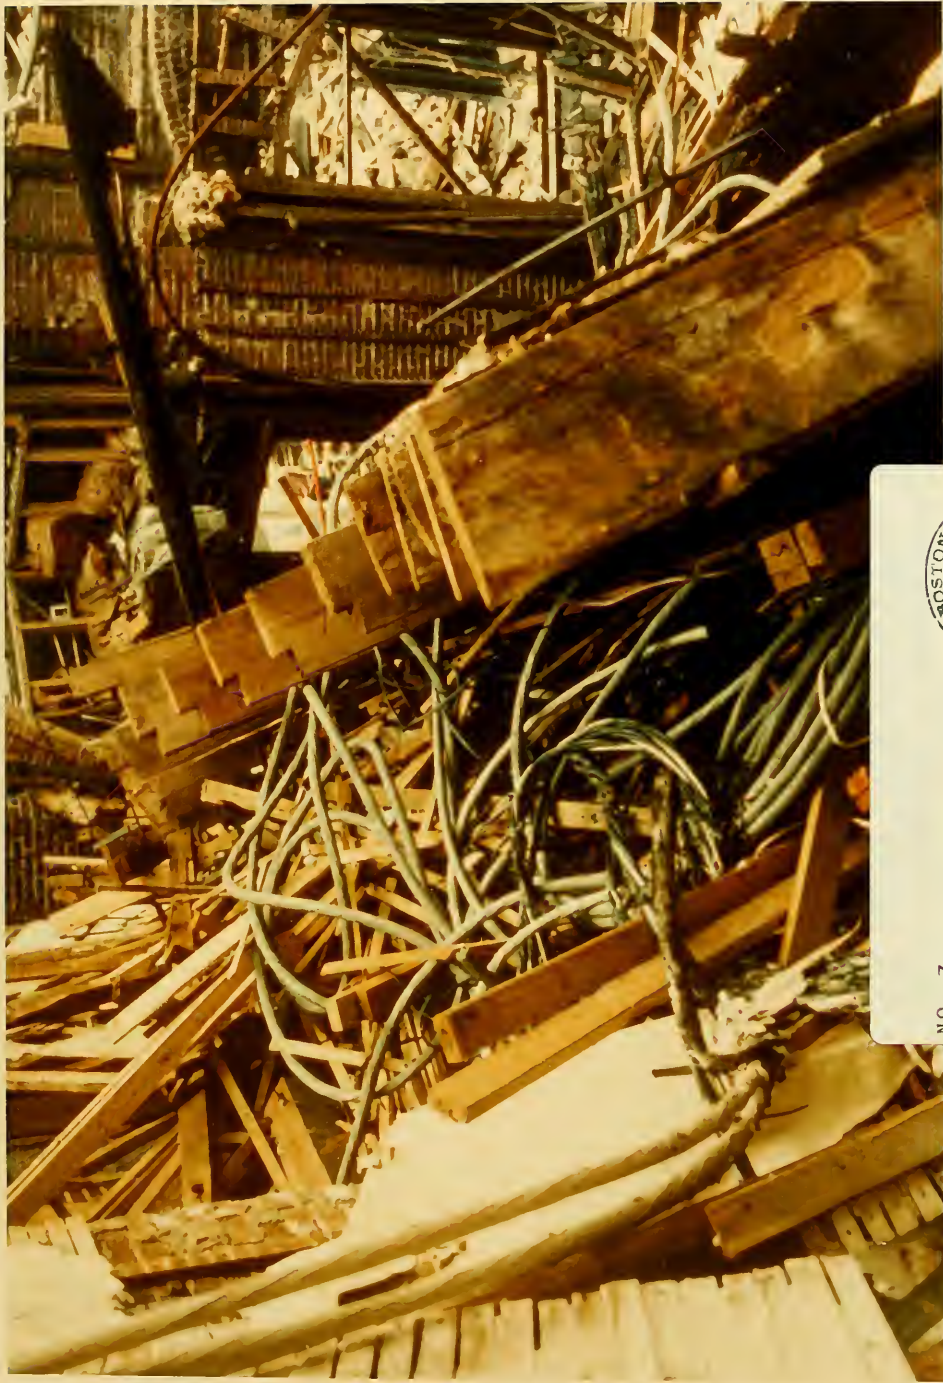
NO. 7
LOOKING EAST AT 5TH FLOOR
IN COLLAPSED POSITION

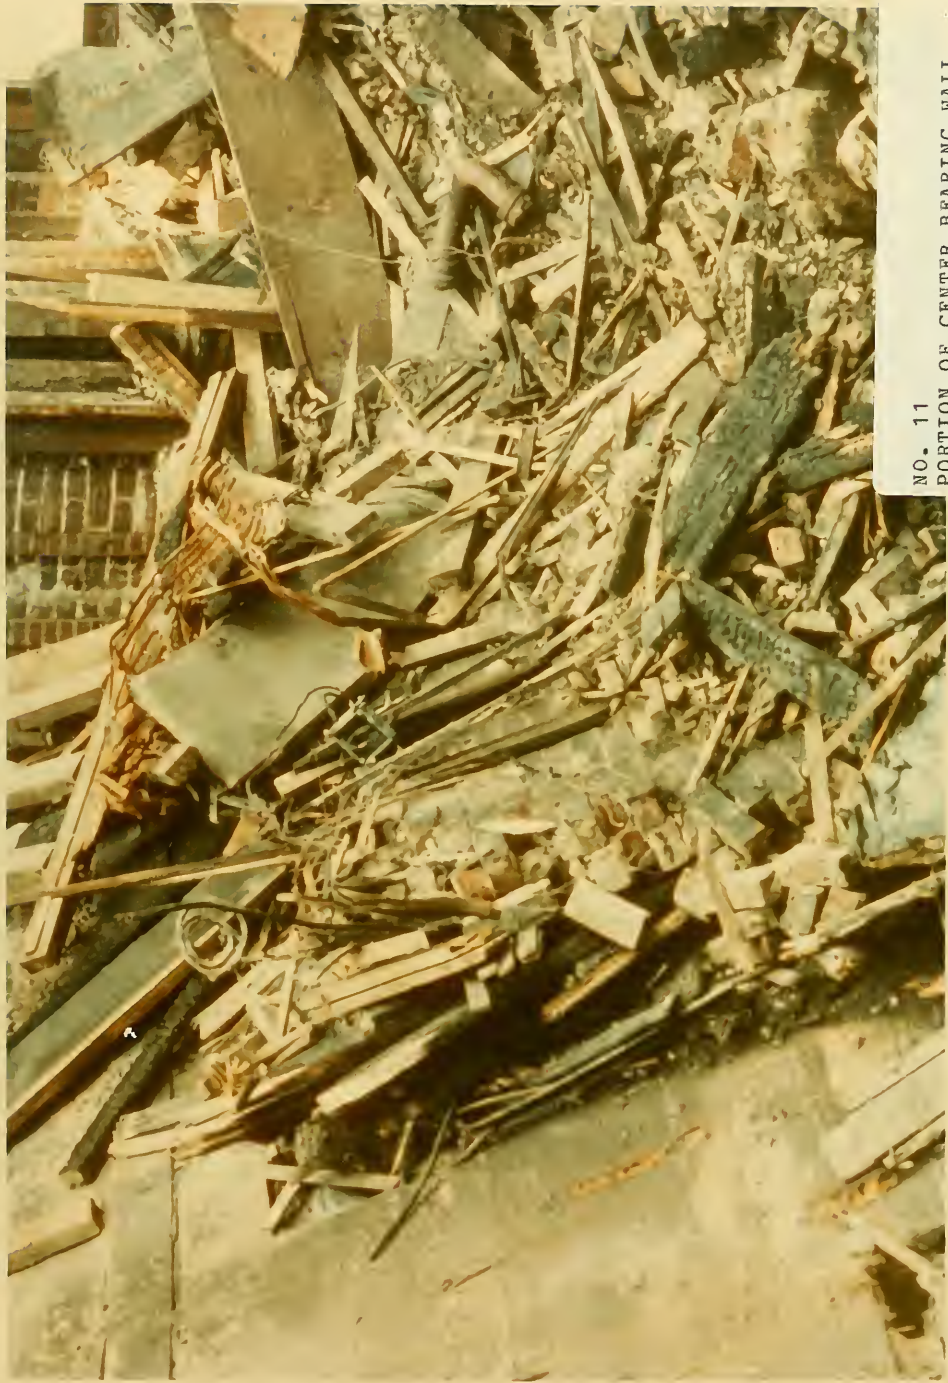
NO. 11

When the North section of the fifth floor was almost completely exposed, during removal of the debris, a portion of the central bearing wall was found laying against it. The bricks and mortar in this portion were intact and there were vertical furring strips on each side. Charred surfaces on each side indicated that this portion originally was located between fifth floor and roof.

PORTION OF CENTER BEARING WALL
LAYING AGAINST 5TH FLOOR—
APPROXIMATELY FOUR STORIES
BELOW ORIGINAL POSITION.

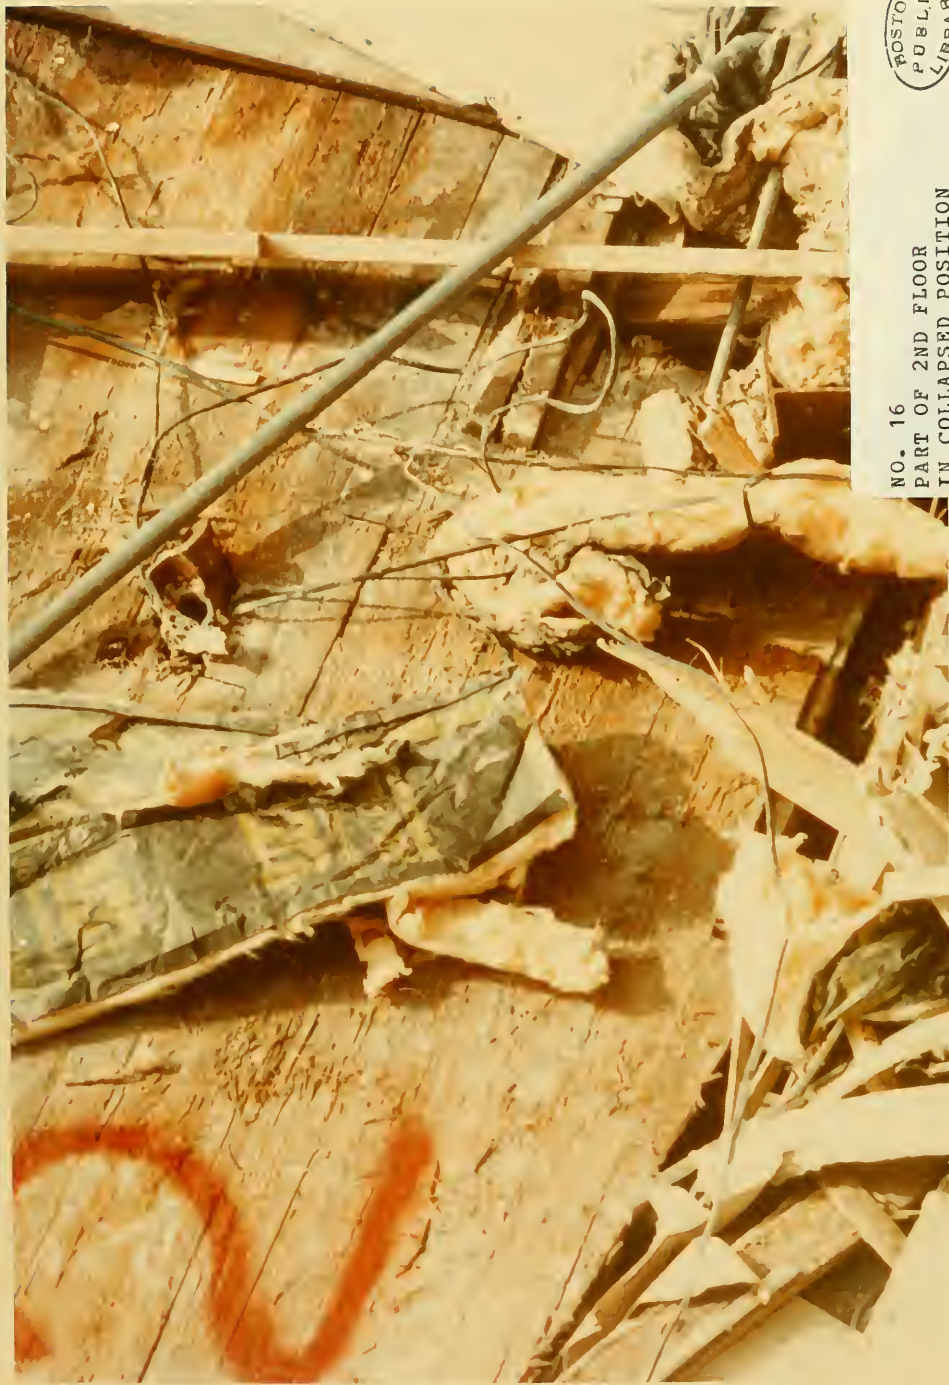
The second floor was lifted out more or less in pieces being locked in by collapsed piping and impaled on protruding steel beams. This Northerly half of the second floor was found to have a structural weakness in that some of the floor joists were not long enough to reach to the central bearing wall. The licensed builder (Mr. Joseph Lazo) stated that this weakness had been discovered during the present alteration and that temporary supports had been placed while the structural engineers analyzed this condition.

NO. 16
PART OF 2ND FLOOR
IN COLLAPSED POSITION
AND IMPALED ON STEEL BEAMS.

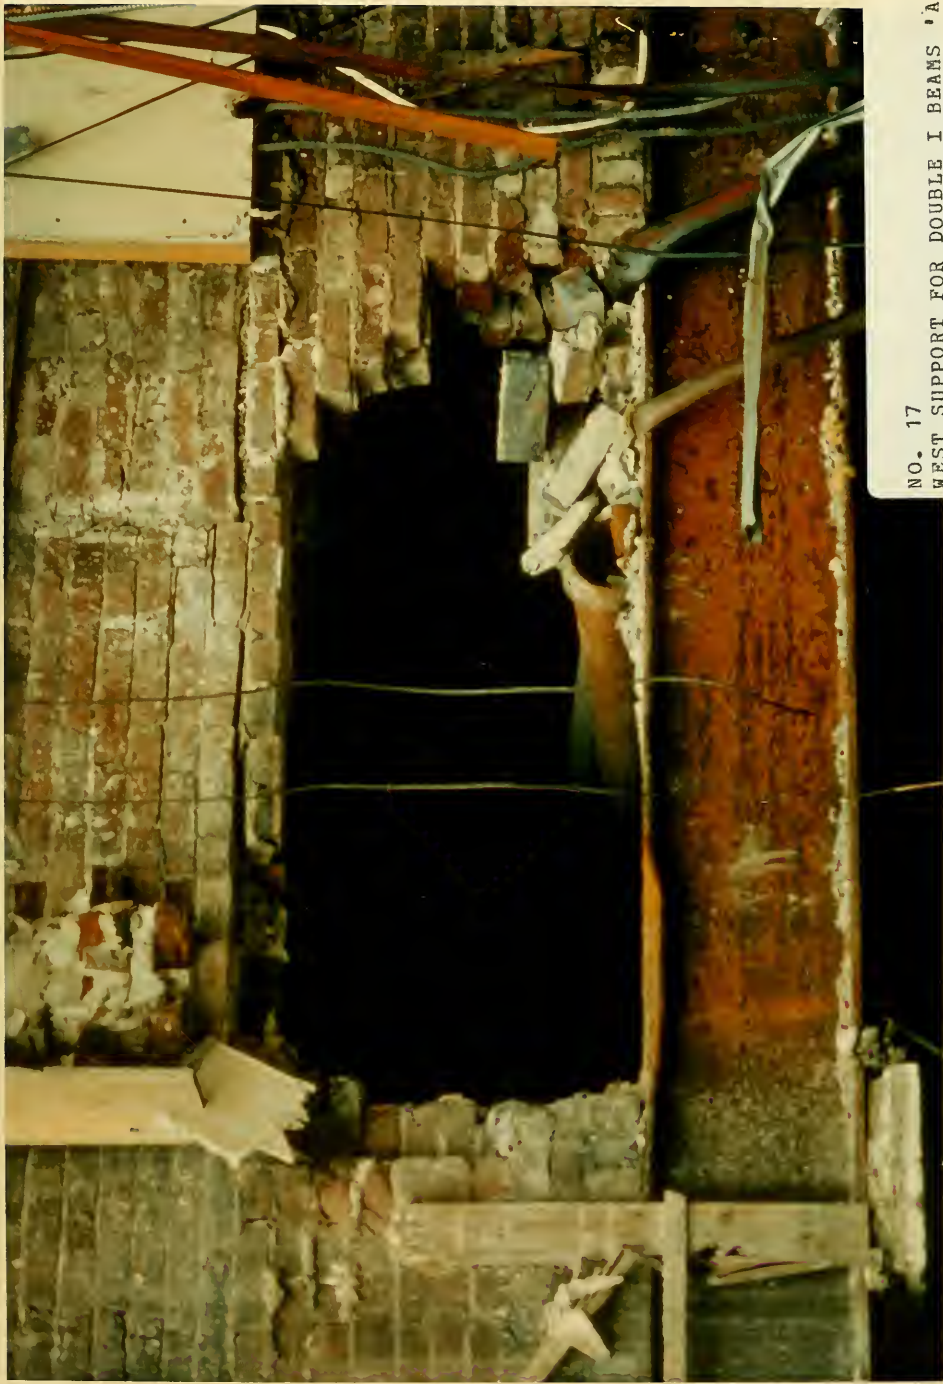
NO. 17

At the West side, the double-I-beams were supported by another set of double beams running north and south. A large rotational force was also set up at this point; a flange of the supporting beam was bent and cracked and a section of brickwork was torn out of the West side bearing wall. The floors in the main part of the building tied into the opposite side of this wall and may have prevented a progression of the collapse in this direction.

WEST SUPPORT FOR DOUBLE I BEAMS 'A'-
NOTE BENT FLANGE AND SECTION
TORN OUT OF WEST WALL

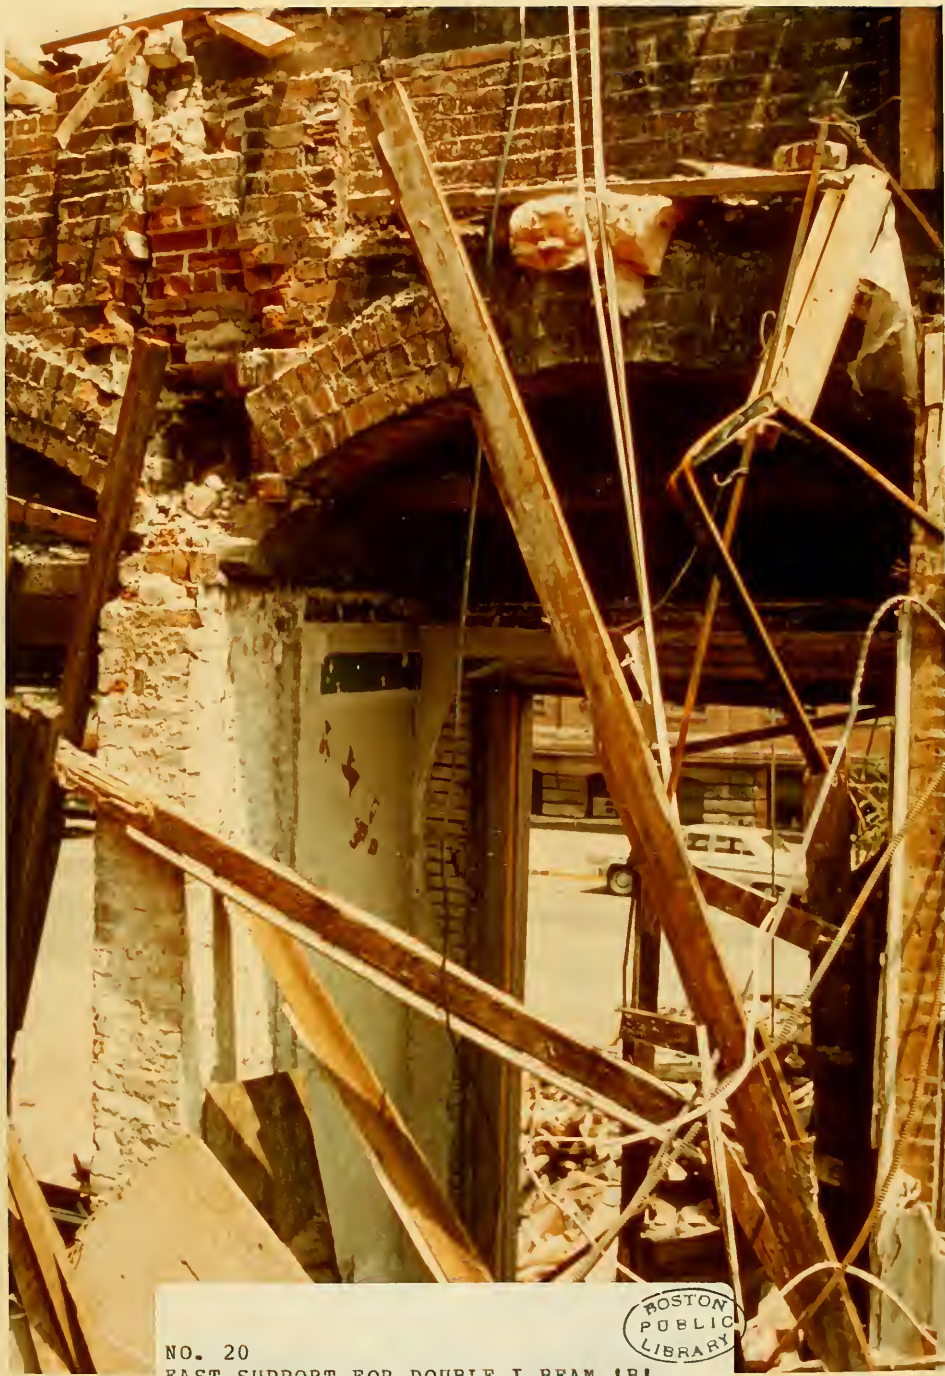
NO. 20

EAST SUPPORT FOR DOUBLE I BEAM 'B'-
NOTE BRICKS TORN OUT BY BEAM ROTATION.

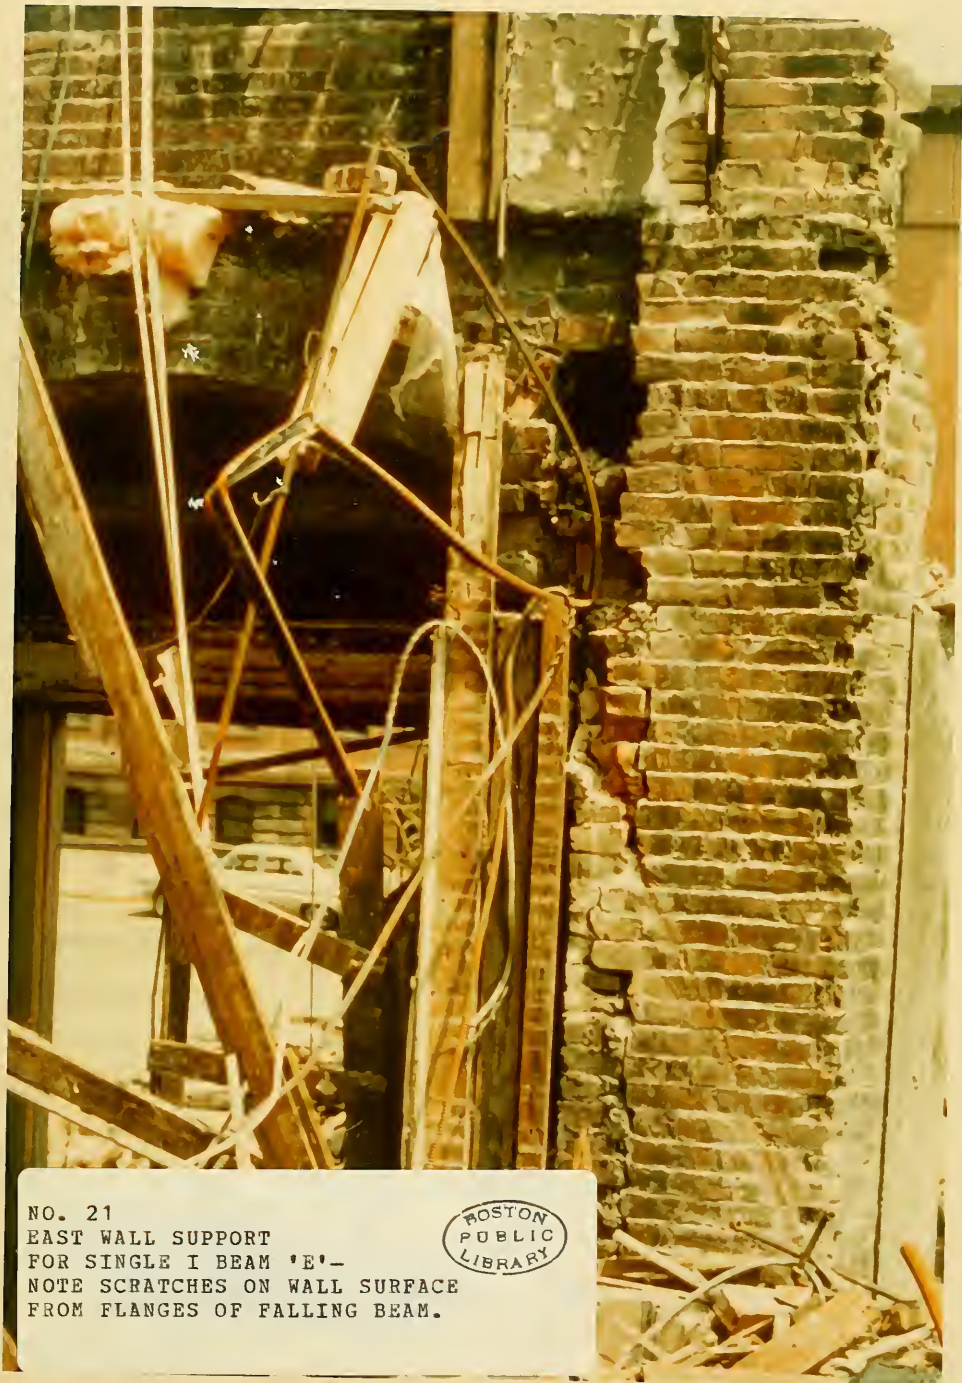
NO. 21
EAST WALL SUPPORT
FOR SINGLE I BEAM 'E'-
NOTE SCRATCHES ON WALL SURFACE
FROM FLANGES OF FALLING BEAM.

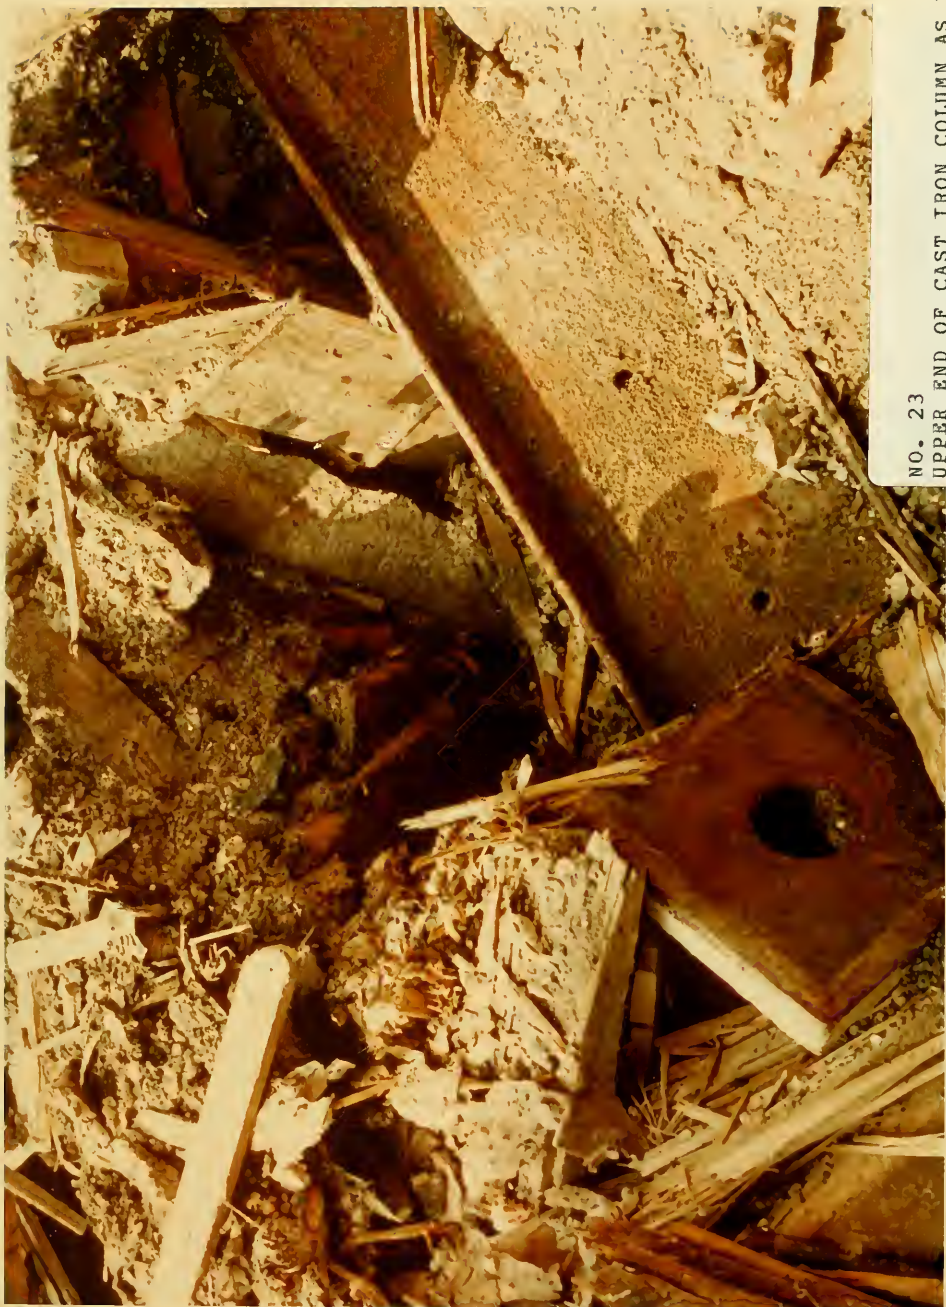
NO. 23

UPPER END OF CAST IRON COLUMN AS FOUND-
WEST SIDE DOUBLE I BEAM 'A' AT RIGHT-
NOTE GRANITE BEARING BLOCK
RESTING ON END IN DOOR OPENING.

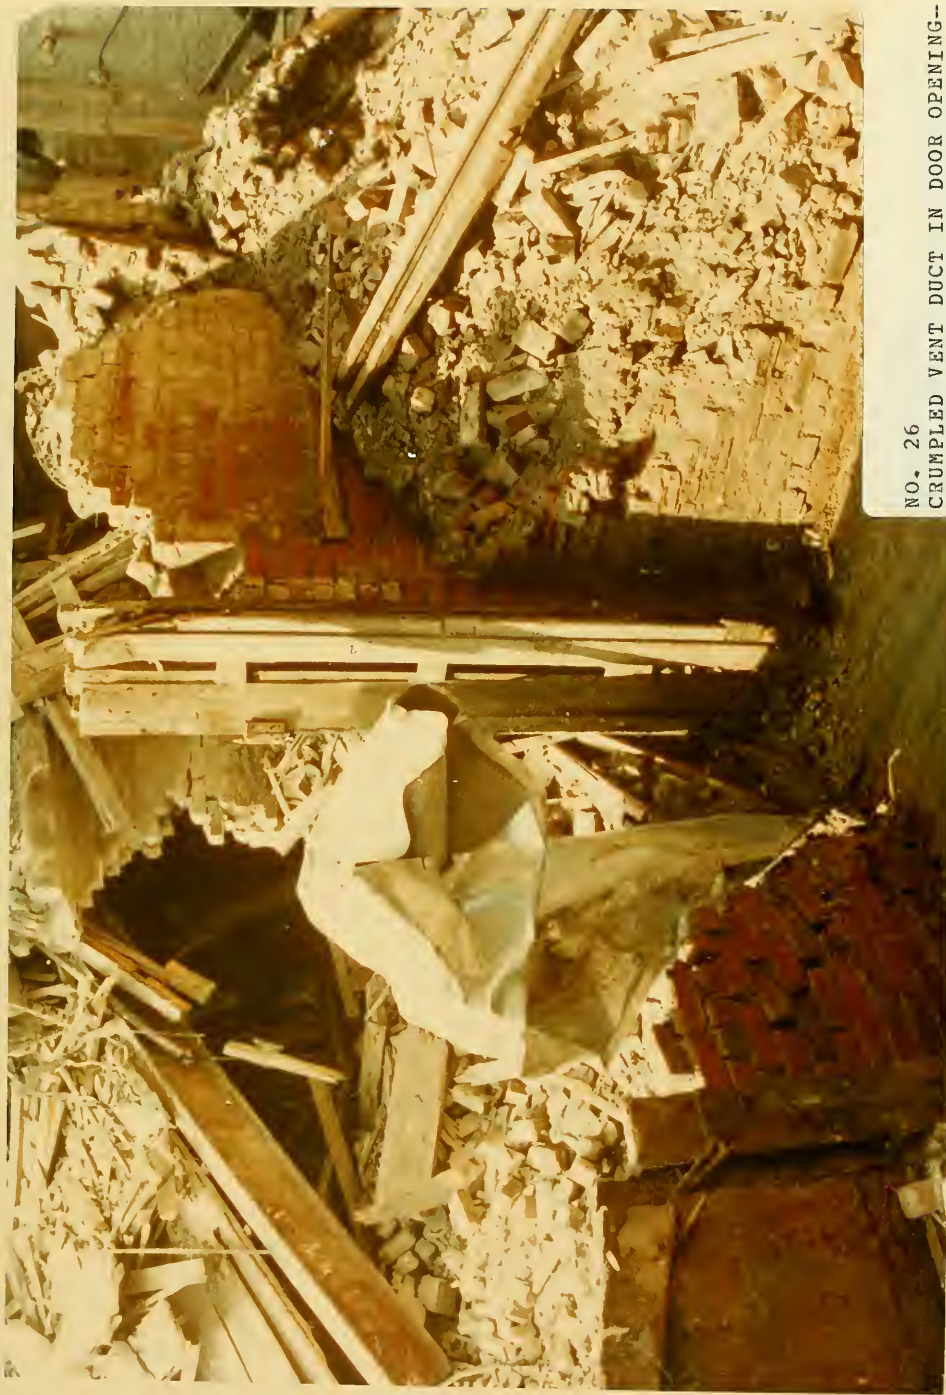
NO. 26

CRUMPLED VENT DUCT IN DOOR OPENING--
ALL DEBRIS CLEARED AWAY NORTH OF WALL--
NOTE DENT IN DUCT WHERE COLUMN RESTED.

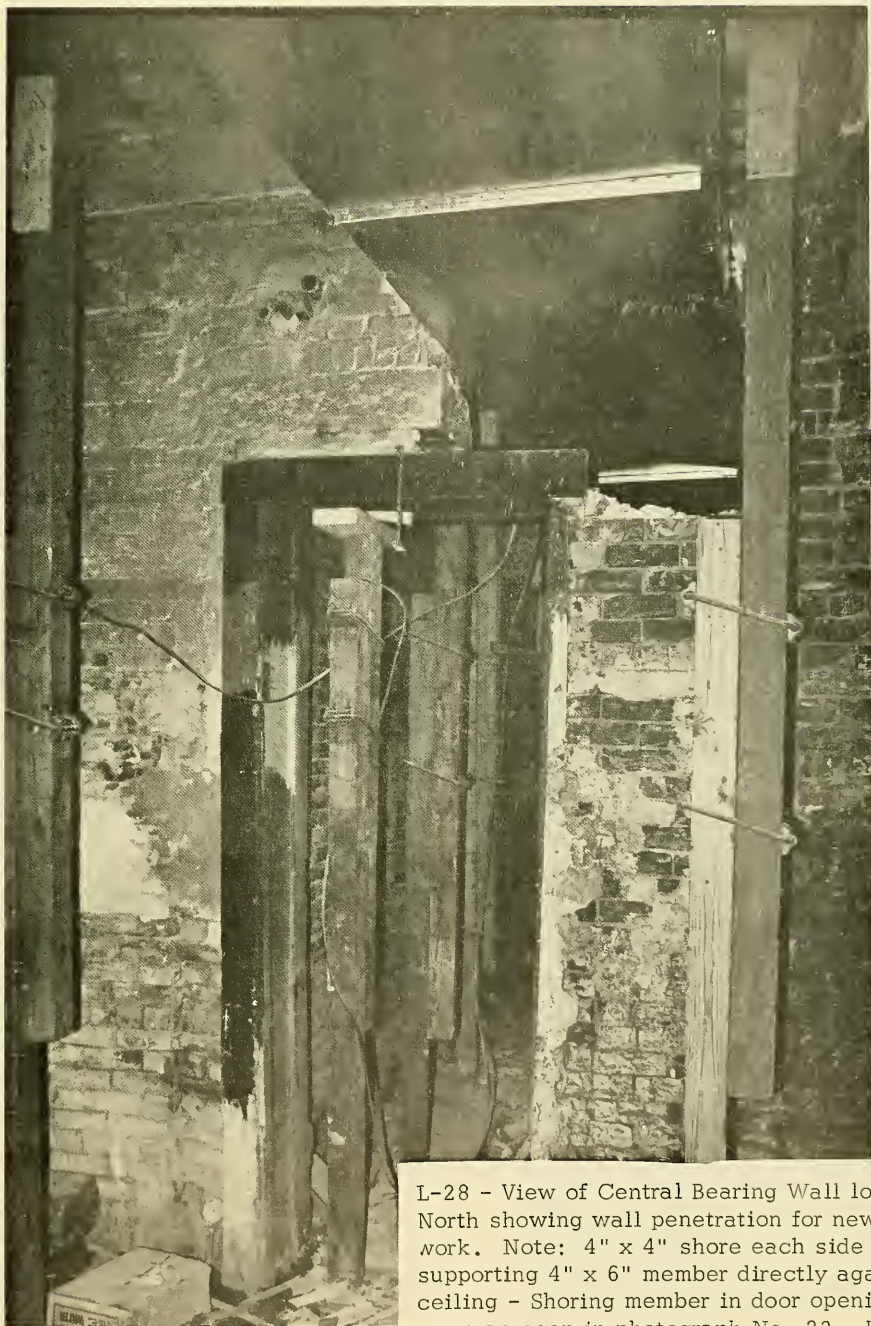
L-28 - View of Central Bearing Wall looking North showing wall penetration for new duct-work. Note: 4" x 4" shore each side of duct, supporting 4" x 6" member directly against ceiling - Shoring member in door opening is same as seen in photograph No. 23. Photograph taken by LeMessurier Associates in 1971.

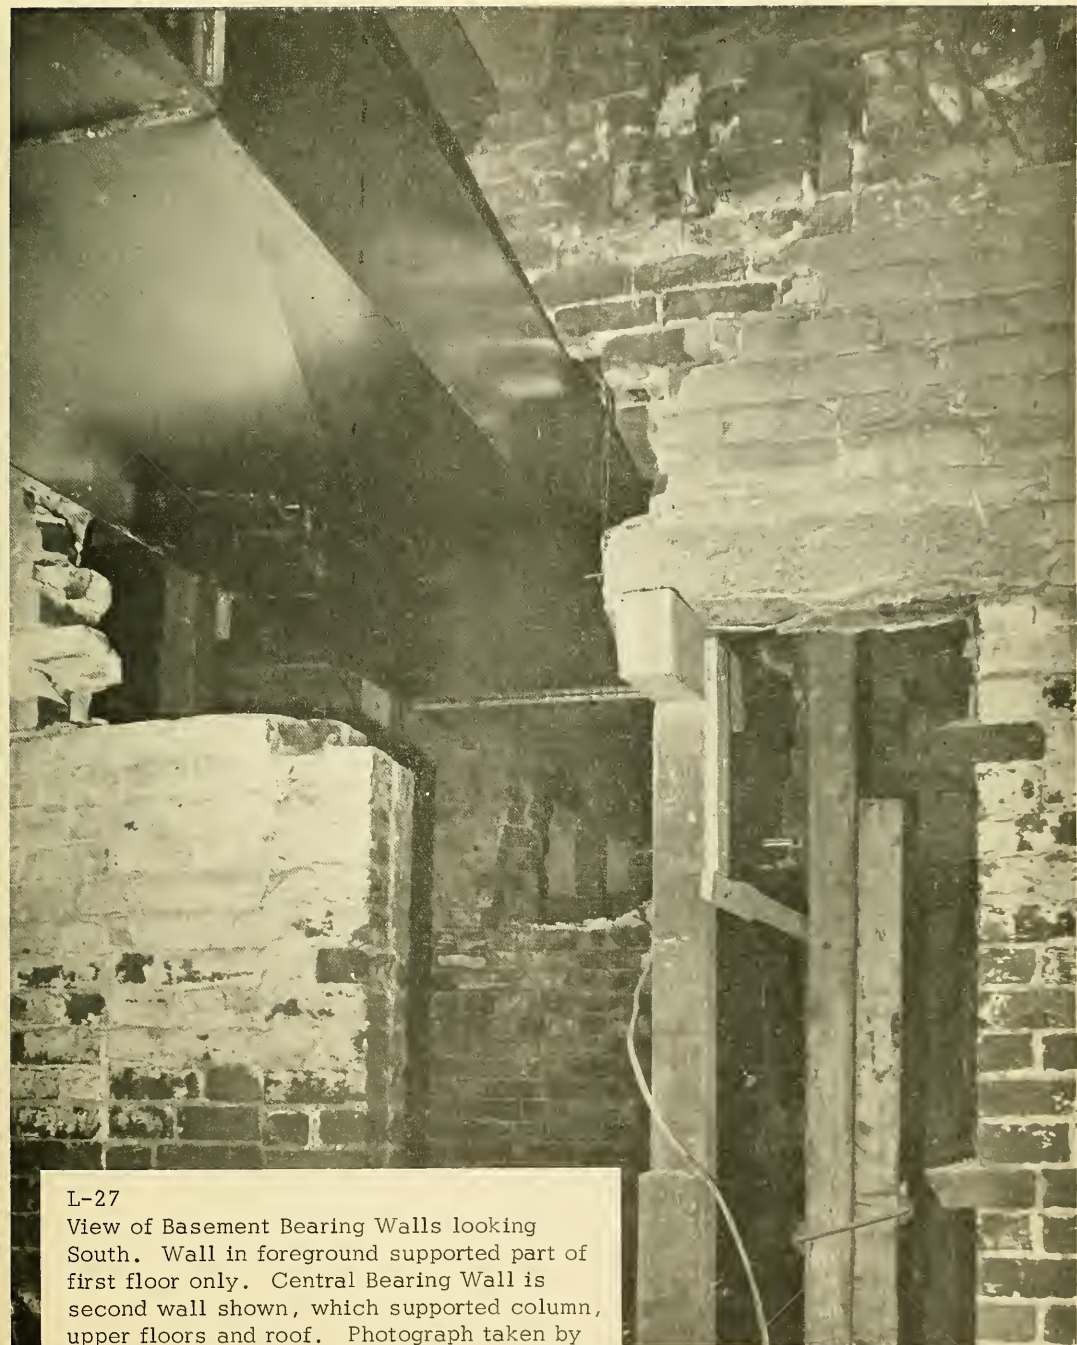
L-27

View of Basement Bearing Walls looking South. Wall in foreground supported part of first floor only. Central Bearing Wall is second wall shown, which supported column, upper floors and roof. Photograph taken by LeMessurier Associates in 1971.
