INVESTIGATION

COLLAPSE

HOTEL VENDOME

CITY OF BOSTON

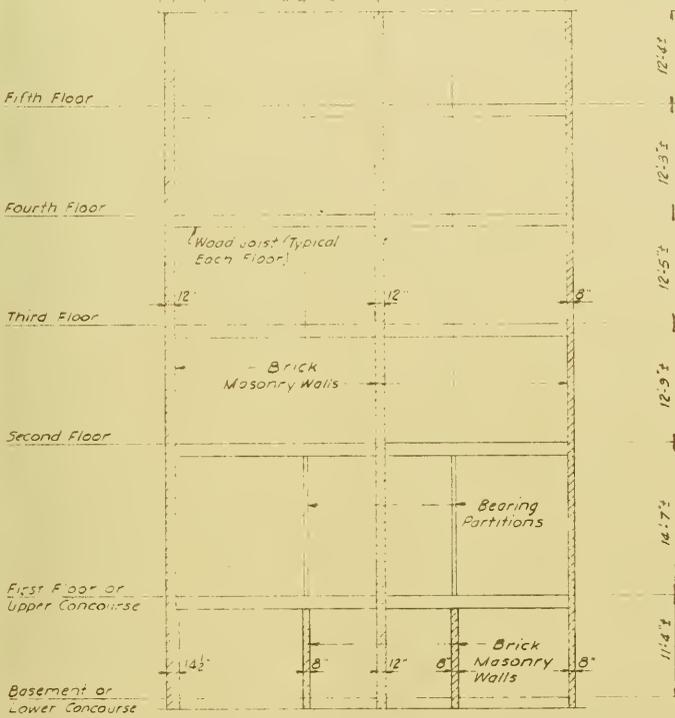
PLATE No. 4

Sometime around 1890 or before, alterations in the first story were made. The C-Line Wall and the partition on the D-Line were removed in this first story. Dual 15-inch wrought iron beams, together with a 7-inch diameter cast iron column at Line 2 were installed to carry the loads of the second floor and the floors above previously carried by the section of wall removed. The partition on the D-Line was replaced by 12-inch wrought beams suspended by a saddle on a 10-inch wrought iron beam spanning between the C-Line and the E-Line along Line 2. The 7-inch diameter column on Line 2 was based on a 12-inch by 12-inch by 2-inch plate directly over the lower portion of the wall at the C-Line.

NOTE:
--- Indicates Second Floor
Support System as Found in
Basement After Collapse.
