CITY OF BOSTON

REPORT
OF
INVESTIGATION OF COLLAPSE
AT
HOTEL VENDOME

AUGUST, 1972

CHAS. T. MAIN, INC.
Engineers

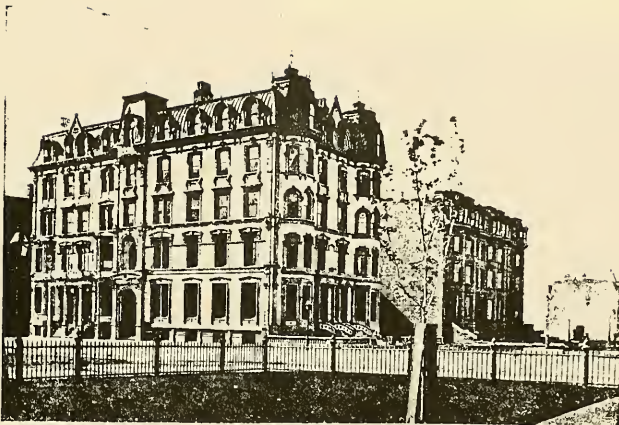
NO. 40
HOTEL VENDOME—
CIRCA 1875 AND CIRCA 1911

COMMONWEALTH AVENUE AT THE CORNER OF DARTMOUTH STREET
Showing the Hotel Vendome before the addition was built.

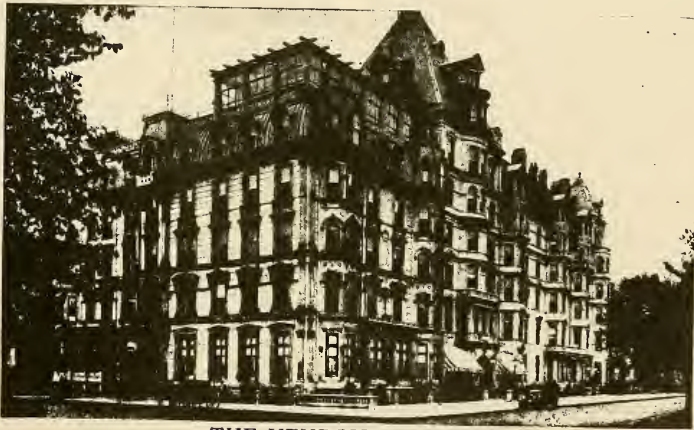
THE VENDOME, BOSTON
Frank H. Abbott & Son

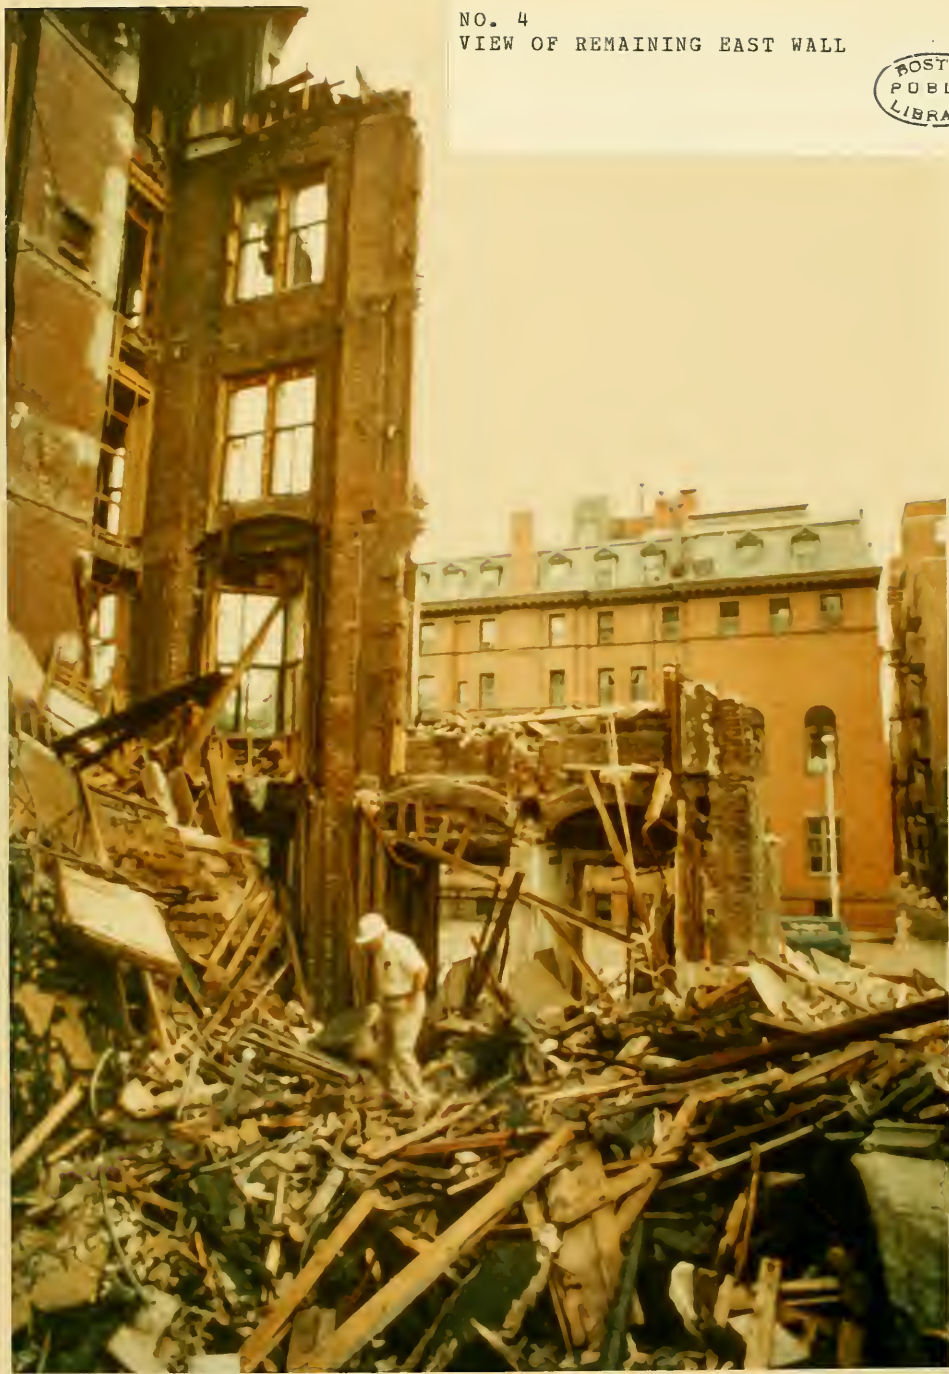
NO. 4

VIEW OF REMAINING EAST WALL

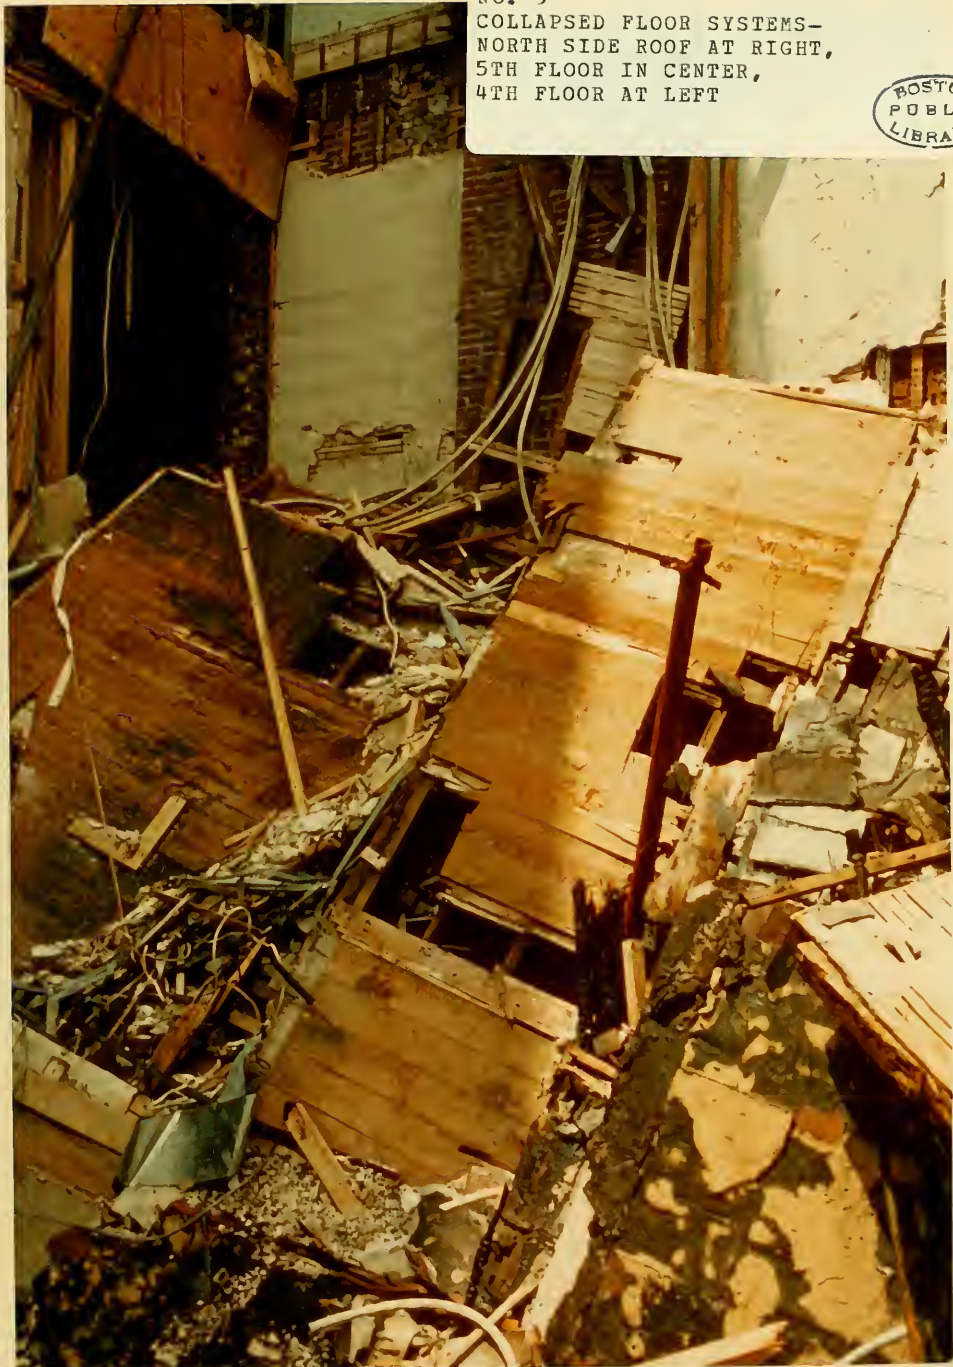
NO. 9

The floors were all collapsed and pitched downward from the sides of the area toward the center. The floor systems appeared to be relatively intact at the Northerly half of the area. Some of the floor systems at the Southerly half were flattened under the great load of bricks from the upper half of the South exterior wall. However, each joist was in its proper position and most joists had suffered only a small amount of damage.

COLLAPSED FLOOR SYSTEMS—
NORTH SIDE ROOF AT RIGHT,
5TH FLOOR IN CENTER,
4TH FLOOR AT LEFT
